BANKLINE DIGITIZING AND IDENTIFYING BLUFF EROSION

Tyler Dardis

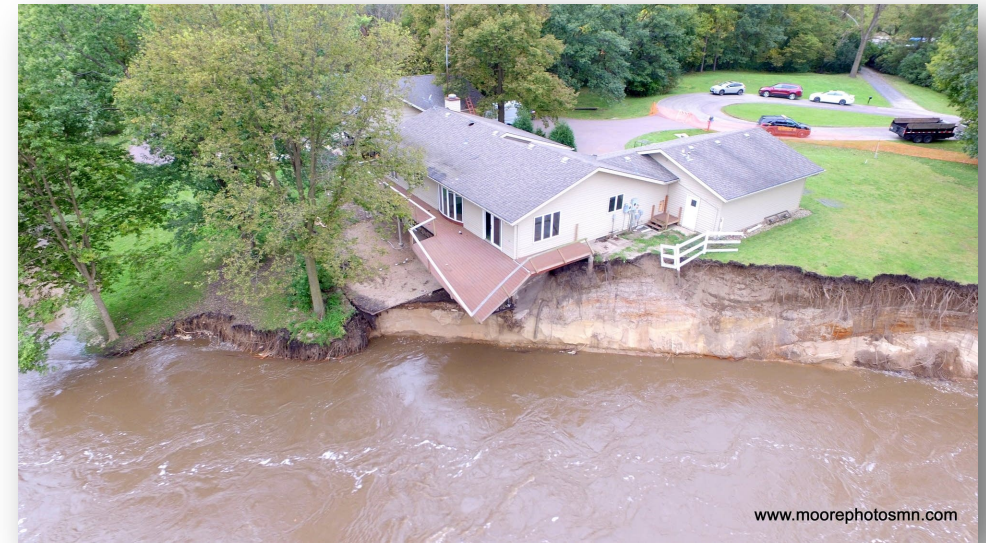
*House on the banks of the Le Sueur river, later demolished due to impacts of erosion

The house has now been demolished, as the deck broke off, and foundation exposed. (see intro page for image)

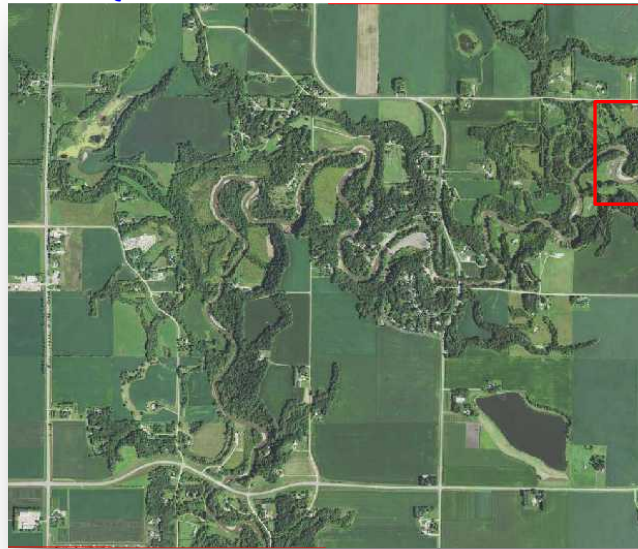
SITE ONE 1939-2017

Between 1939 and 2017, there was a **225 foot change** in the river banks. This is one of the more severe cases, that has cut into the land, removing an obvious amount of land and sediment.

Many accredit this is to increased water flow due to tiling, and other human activities.

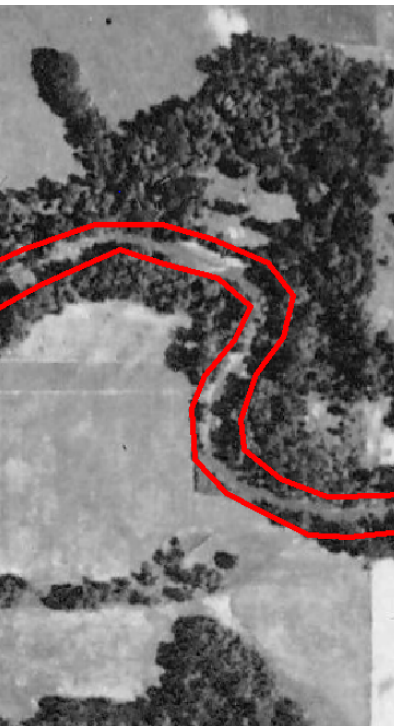
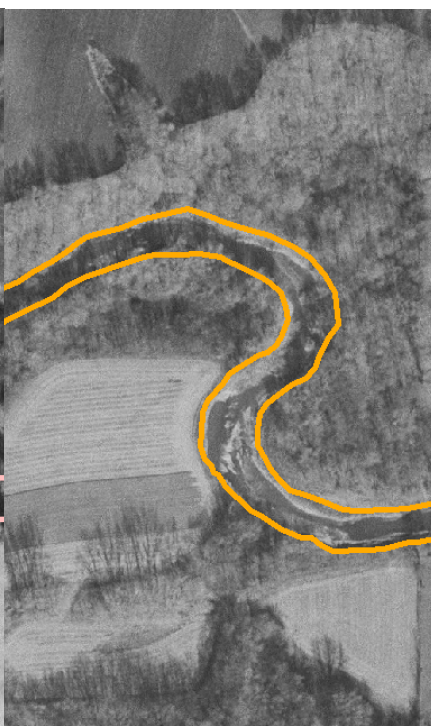
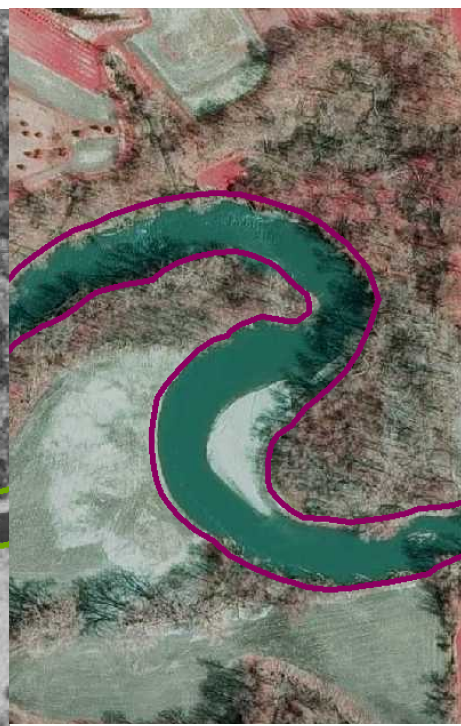
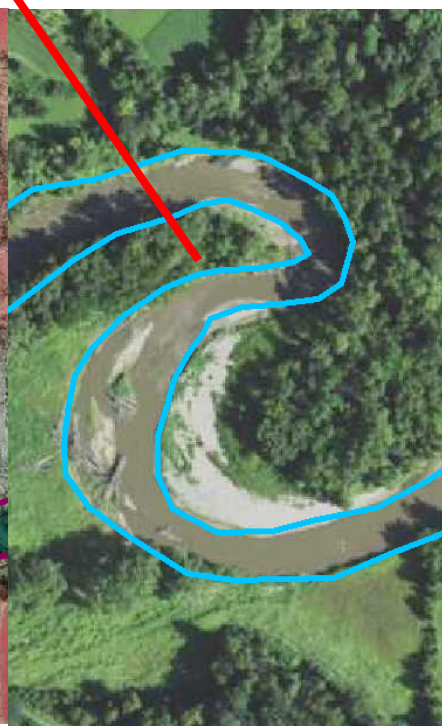
SITE ONE 1939-2017

1939

1949

1973

1991

2011

2017

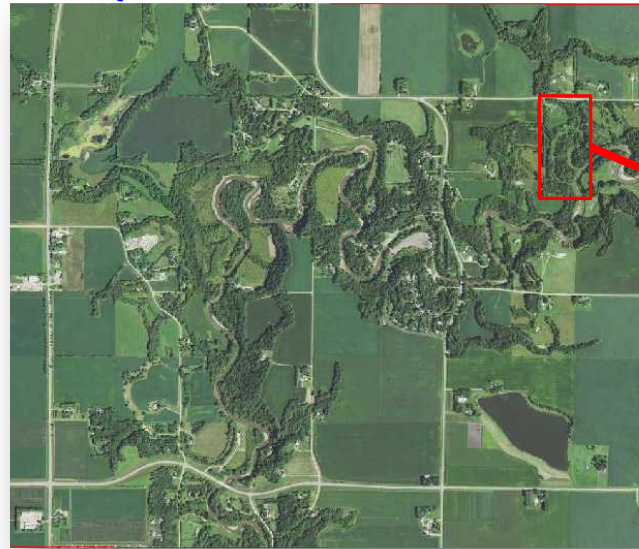
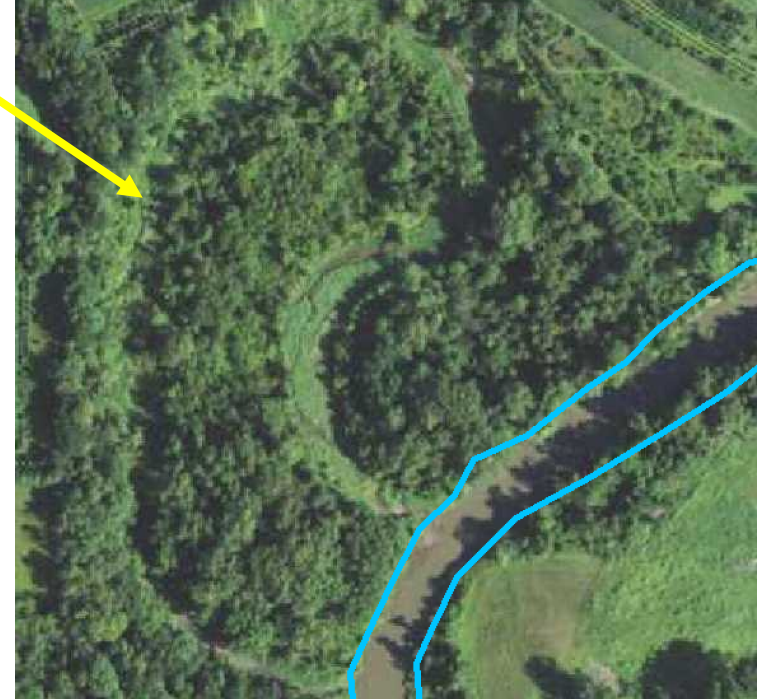
SITE TWO 1991-2011

Between the times of 1991 and 2011, the river cut through a thin piece of land, creating an **oxbow lake** (remnants of a past river) and changing the river direction, flow, etc.

Oxbow Lake
(nearly dried out)

- 1991
- 2017

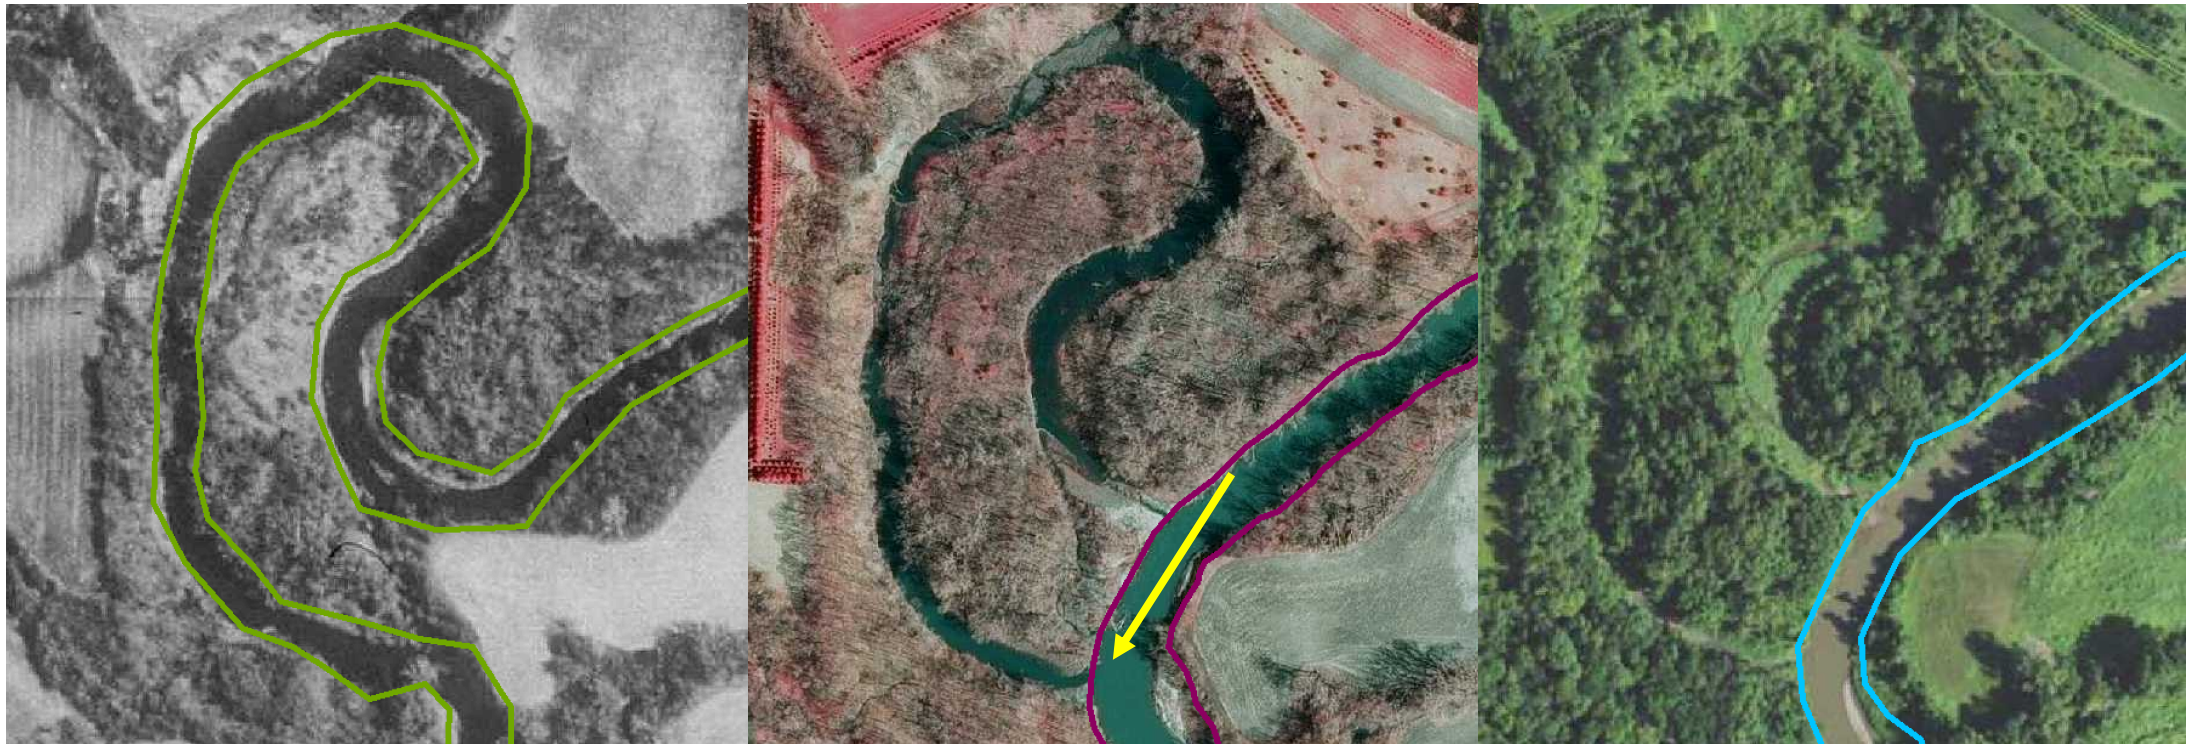
SITE ONE 1991-2017

1991

2011 (break through)

2017

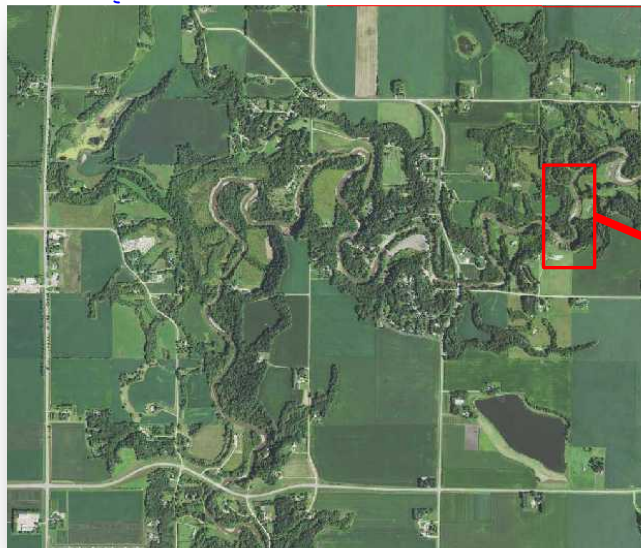
SITE THREE 1939-2017

Downstream from the now oxbow lake, the river has seen a noticeable **meander**, and alter in land. Located at a bend in the river, there is considerable bluff erosion.

Bluff Erosion

— 1939

— 2017

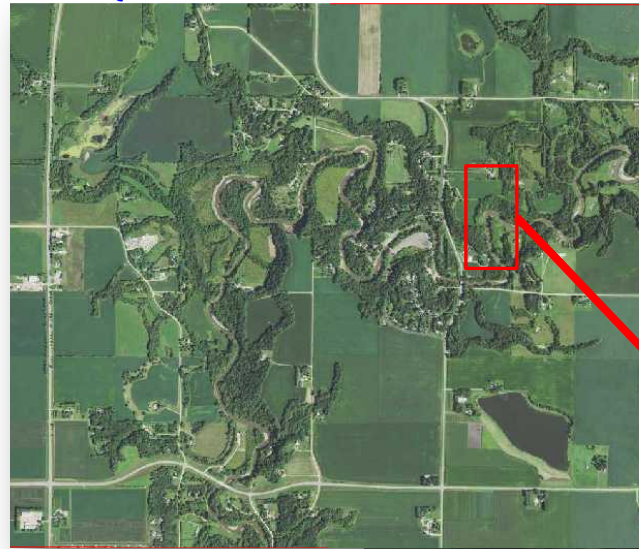
SITE FOUR 1939-2017

At the next bend in the river of the study site, there is another case of river meandering, and widening. There is a very large erosional bluff, but has seen little change over the years, compared to the river.

- 1939 (width: 52ft)
- 1973 (width: 46ft)
- 2017 (width: 66ft)

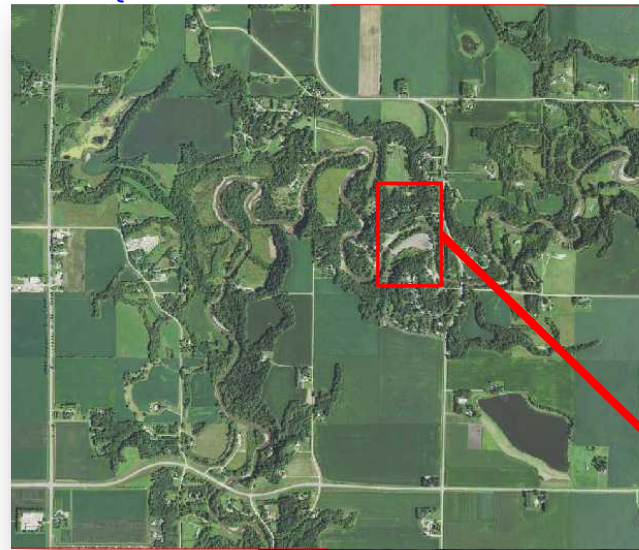
SITE FIVE 1991-2017

This example shows the real magnitude of the effects on humans, and their built environment. A house continually lost property, mainly in the past decade.

**Demolished
House
Location**
**Immediate
Risk Home**

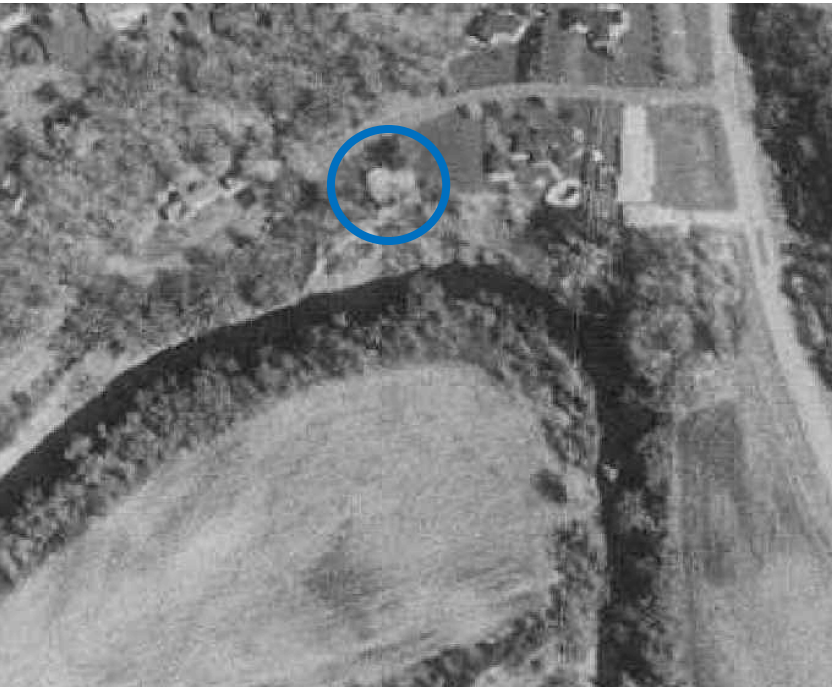
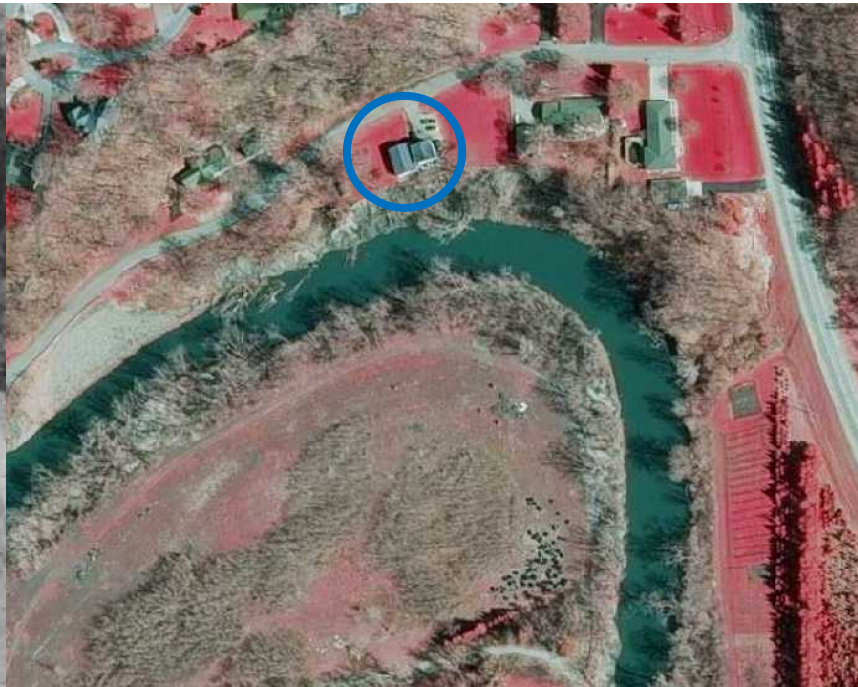
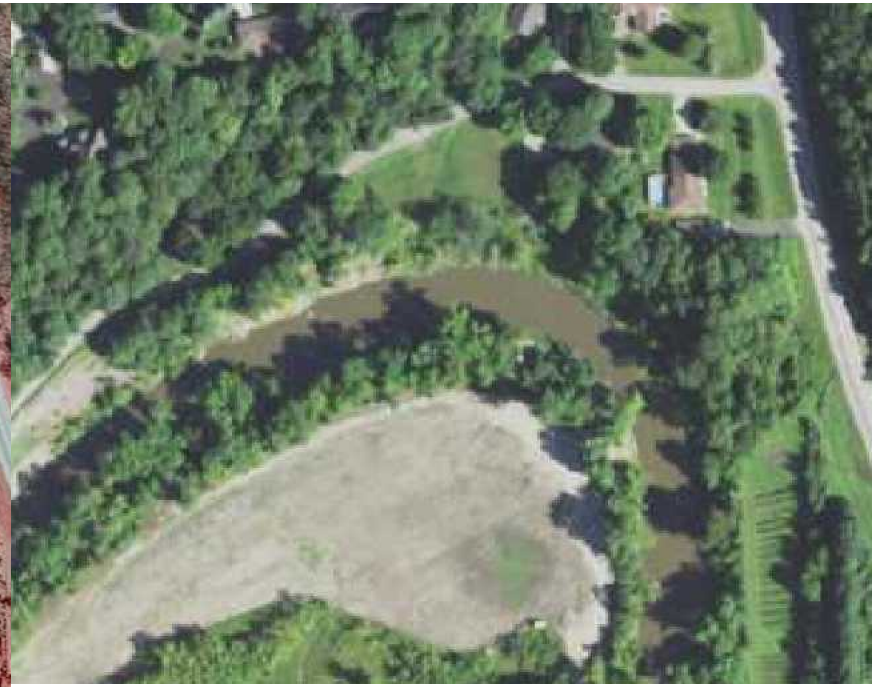
SITE FIVE 1991-2017

1991

2011

2017 (house removed)

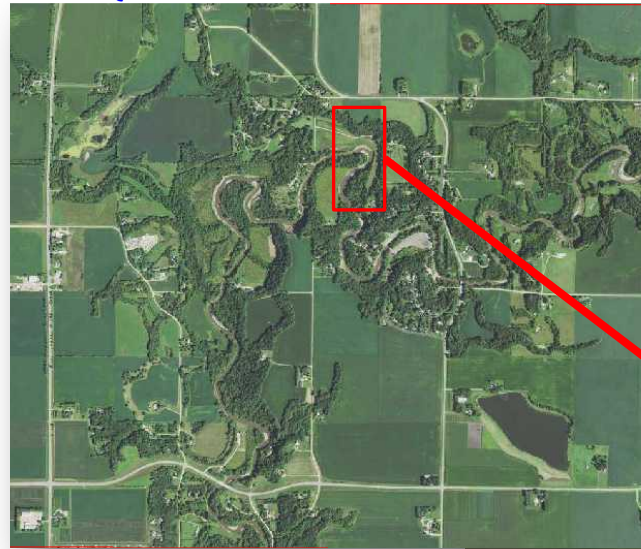
SITE SIX 1939-2017

At this bend in the river, there is once again considerable erosion. This area has very little to no vegetation that can be seen in the 2017 image (current) and the others (next slide).

— 1939
— 2017

Deposition on
opposite of erosion

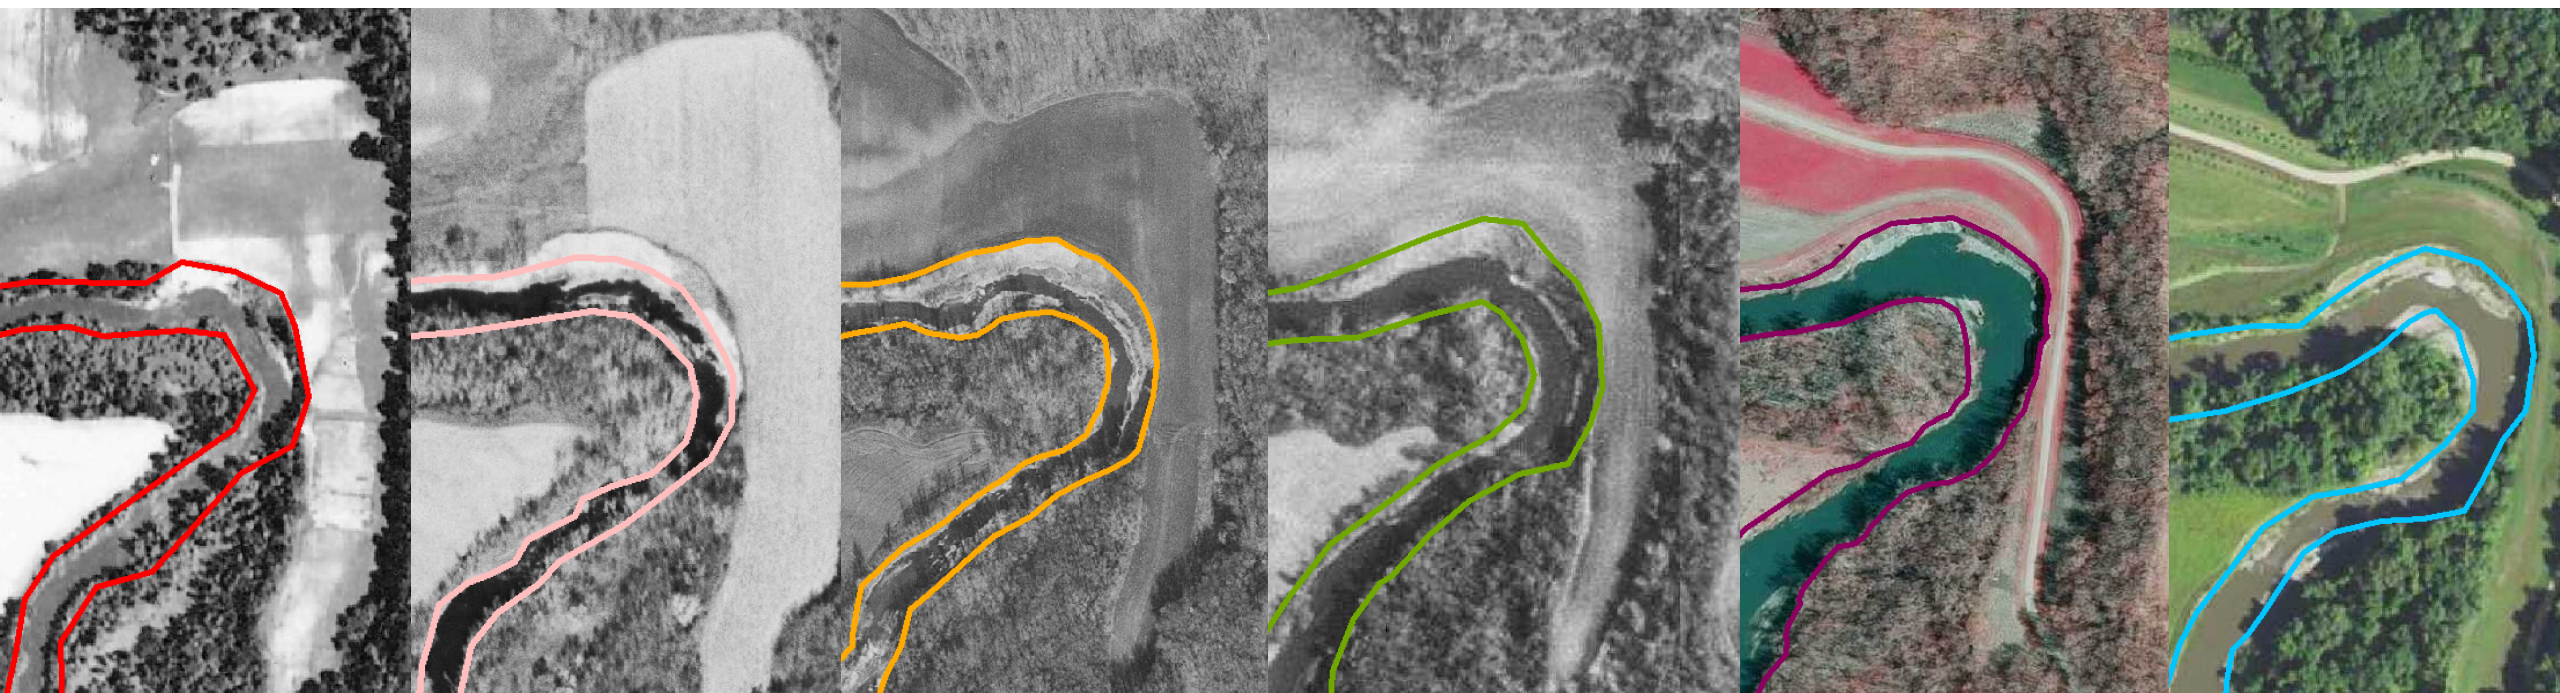
SITE SIX 1939-2017

*Notice low vegetation on erosional slopes

1939

1949

1973

1991

2011

2017

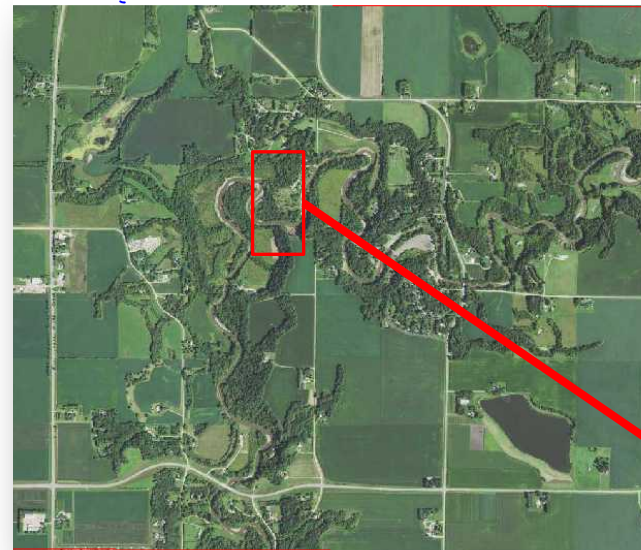
SITE SEVEN 1939-2017

Final spot of erosional concern is yet again at the bend of the river, and the erosional has increased by 60 feet (skewed by slope)

- 1939
- 1991
- 2017

Deposition on opposite of erosion

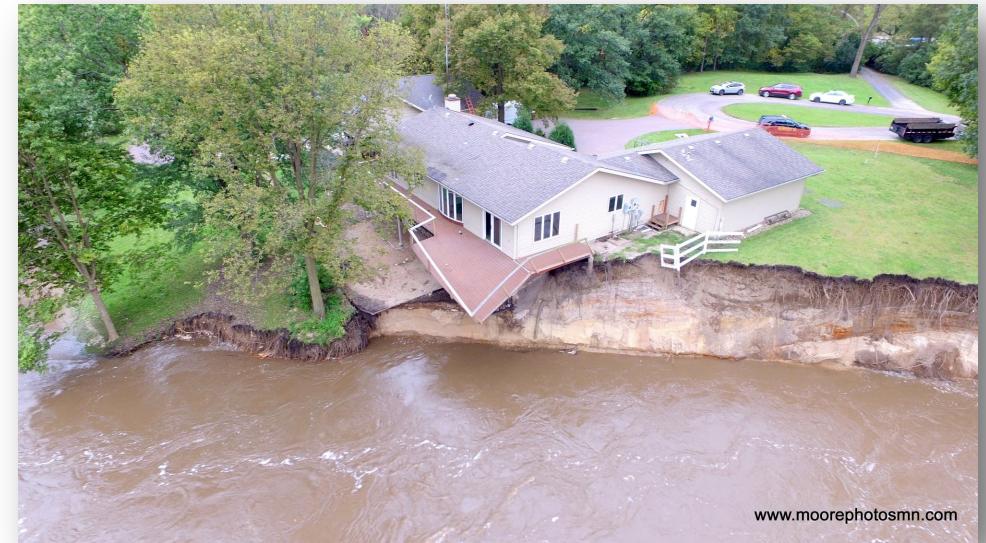
*House on the banks of the Le Sueur river, later demolished due to impacts of erosion
