Chandler Air Force Base

Historical Photographic Analysis

Tyler Dardis
Minnesota State University, Mankato
GEOG 480 – GISc and Environmental Hazards

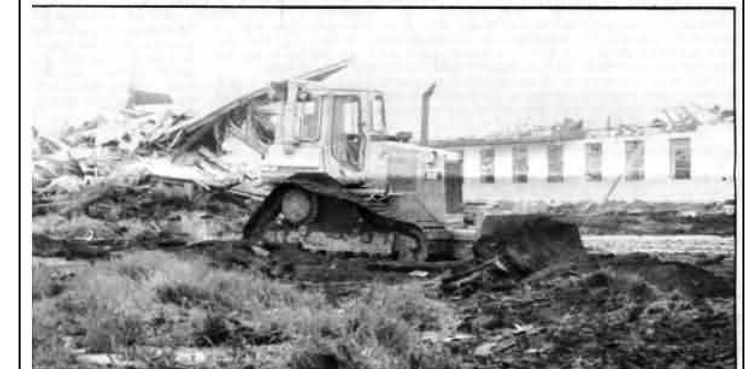
The demolition was complete. The burial was taking place. Deep holes were dug and the remains of the buildings pushed in and covered up. 6-9-93

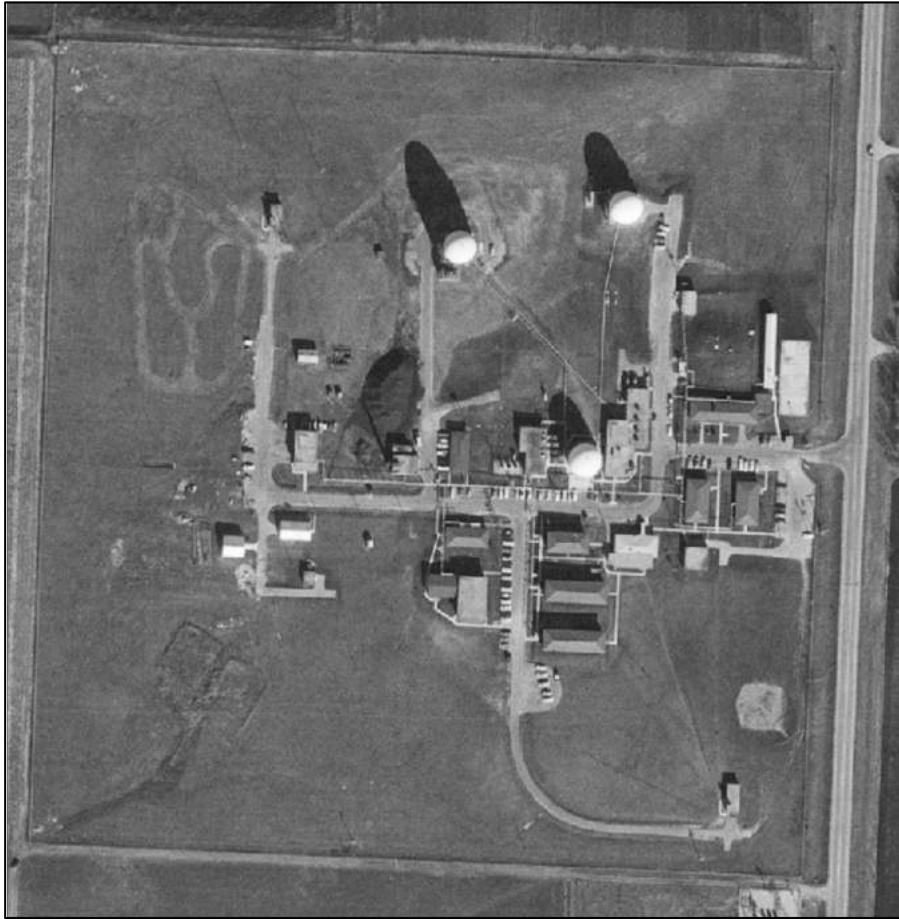
Past v. Present Site of AFB

1965

2018

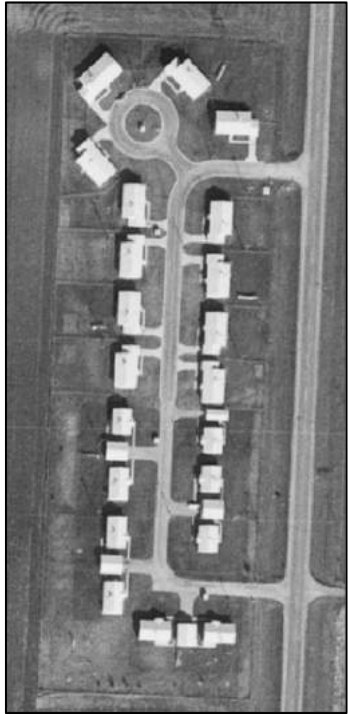
North of the base itself, a small neighborhood of 21 houses housed the officers. At the peak of operations, there were a total of 220 personnel at Chandler AFB.

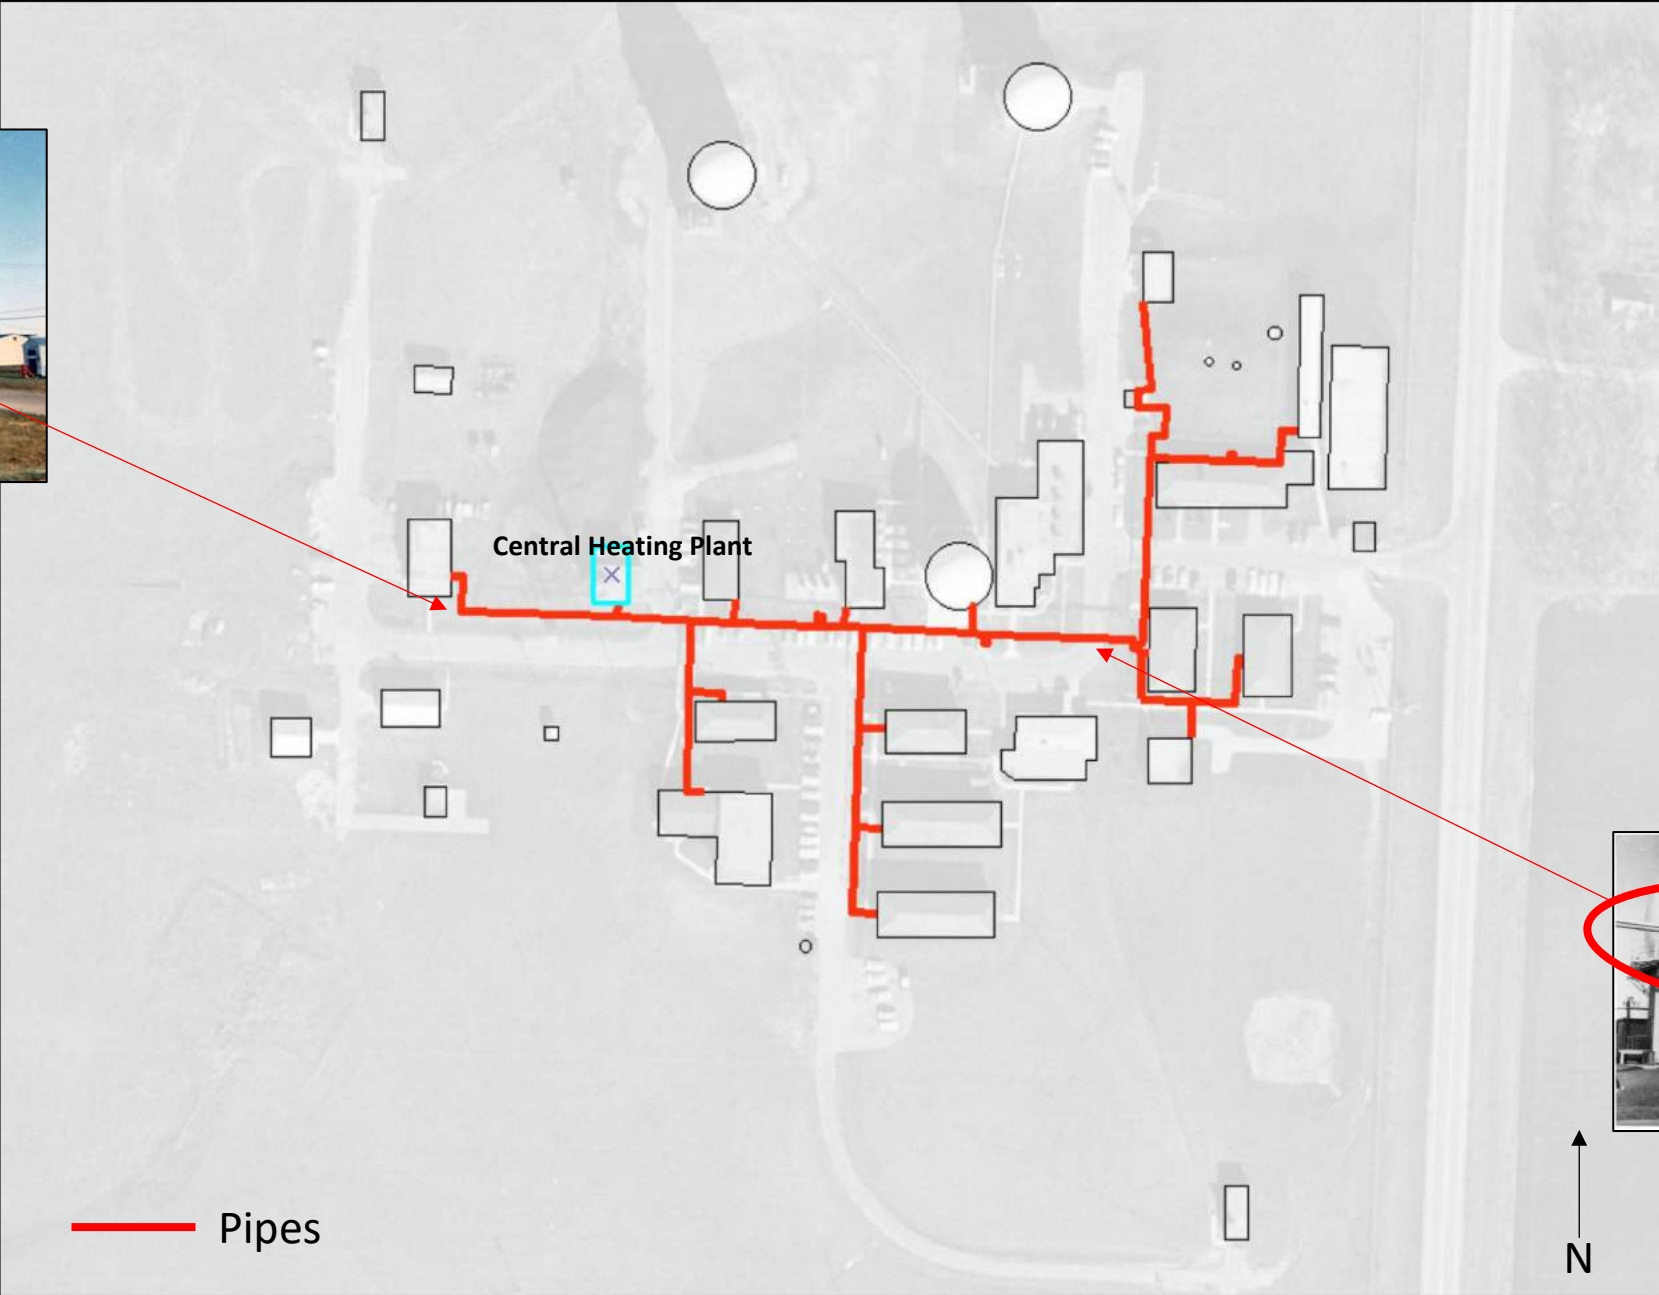
Heating Pipes Overhead, 1965

Pipes have risk of being lined with asbestos for insulation. Possible health hazard is unearthed and exposed due to deterioration of pipes.

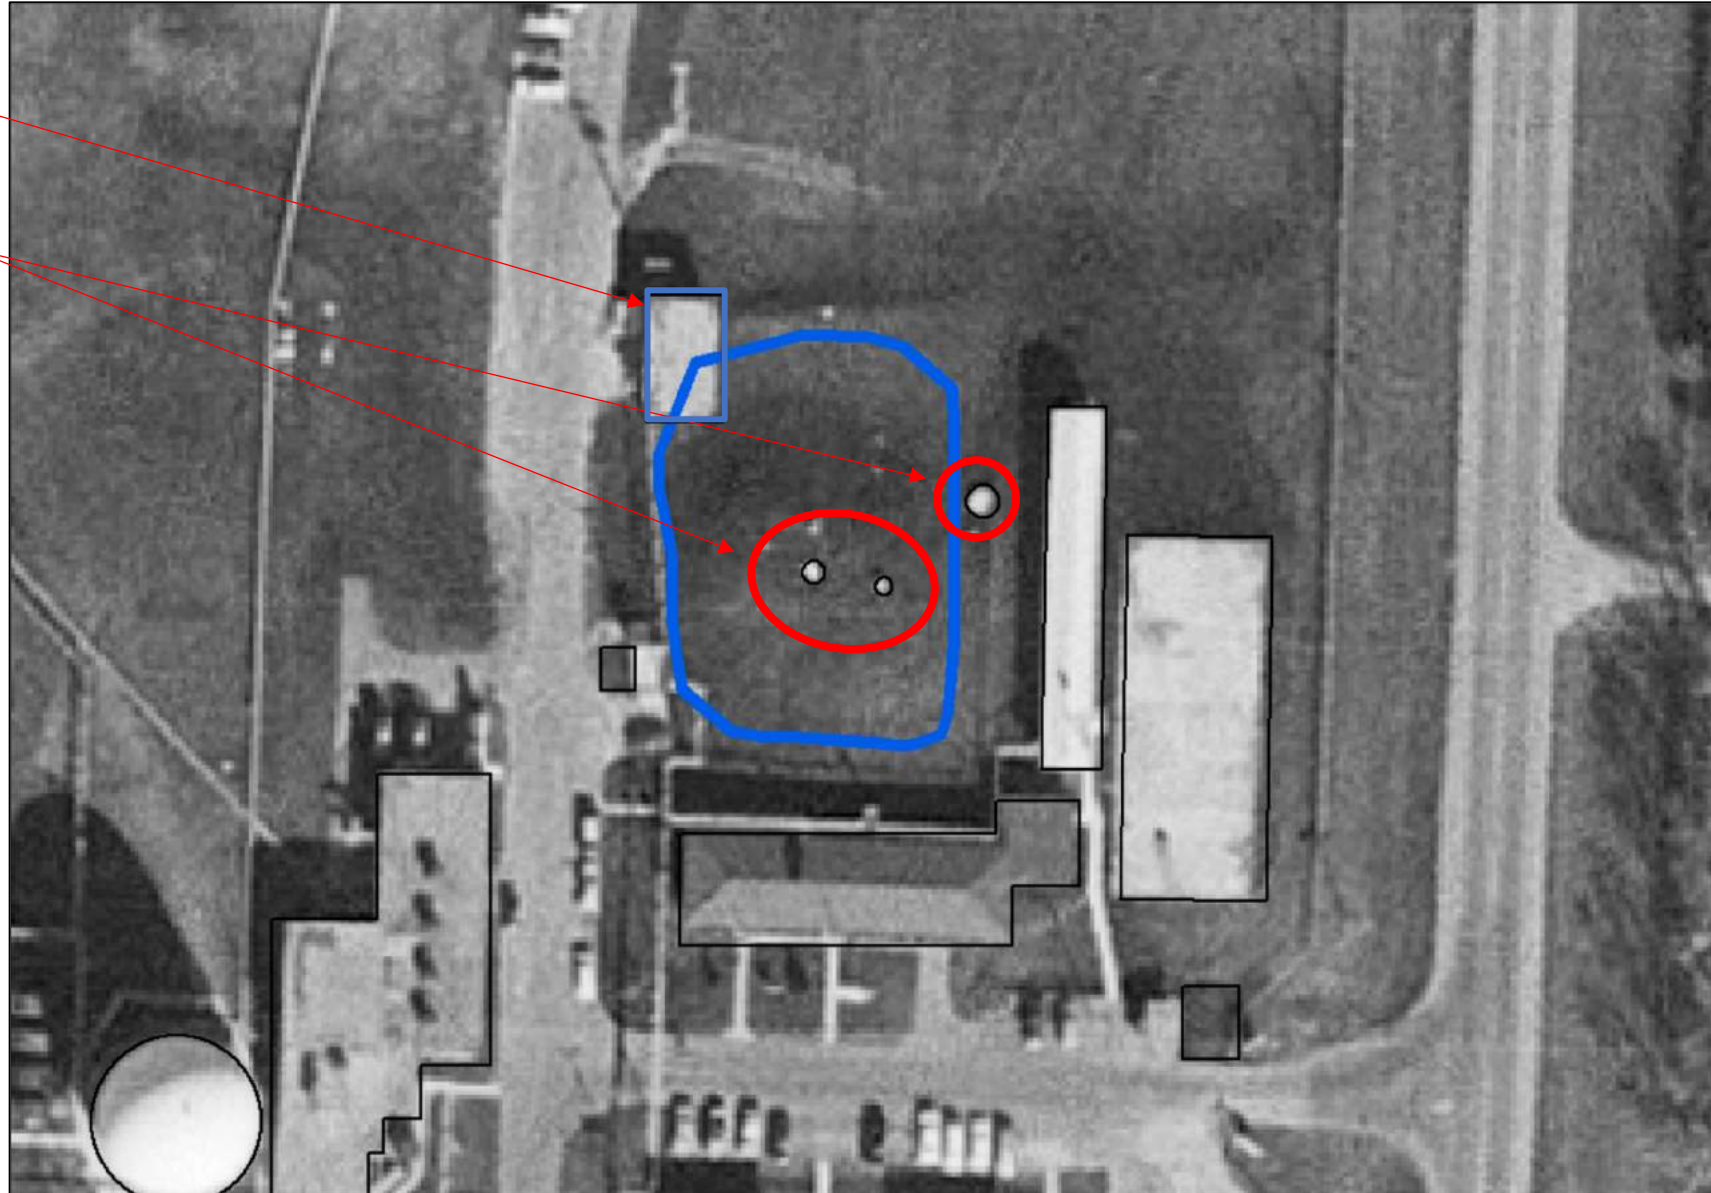
Water Tank Location, 1965

Based off of information relating to the pump house, it states a 12,000 gallon water tank located at the pump house. Looking in stereo at the site, there is a slight mound and pipes erected from the ground. This seems to be the most likely location for the underground tank.

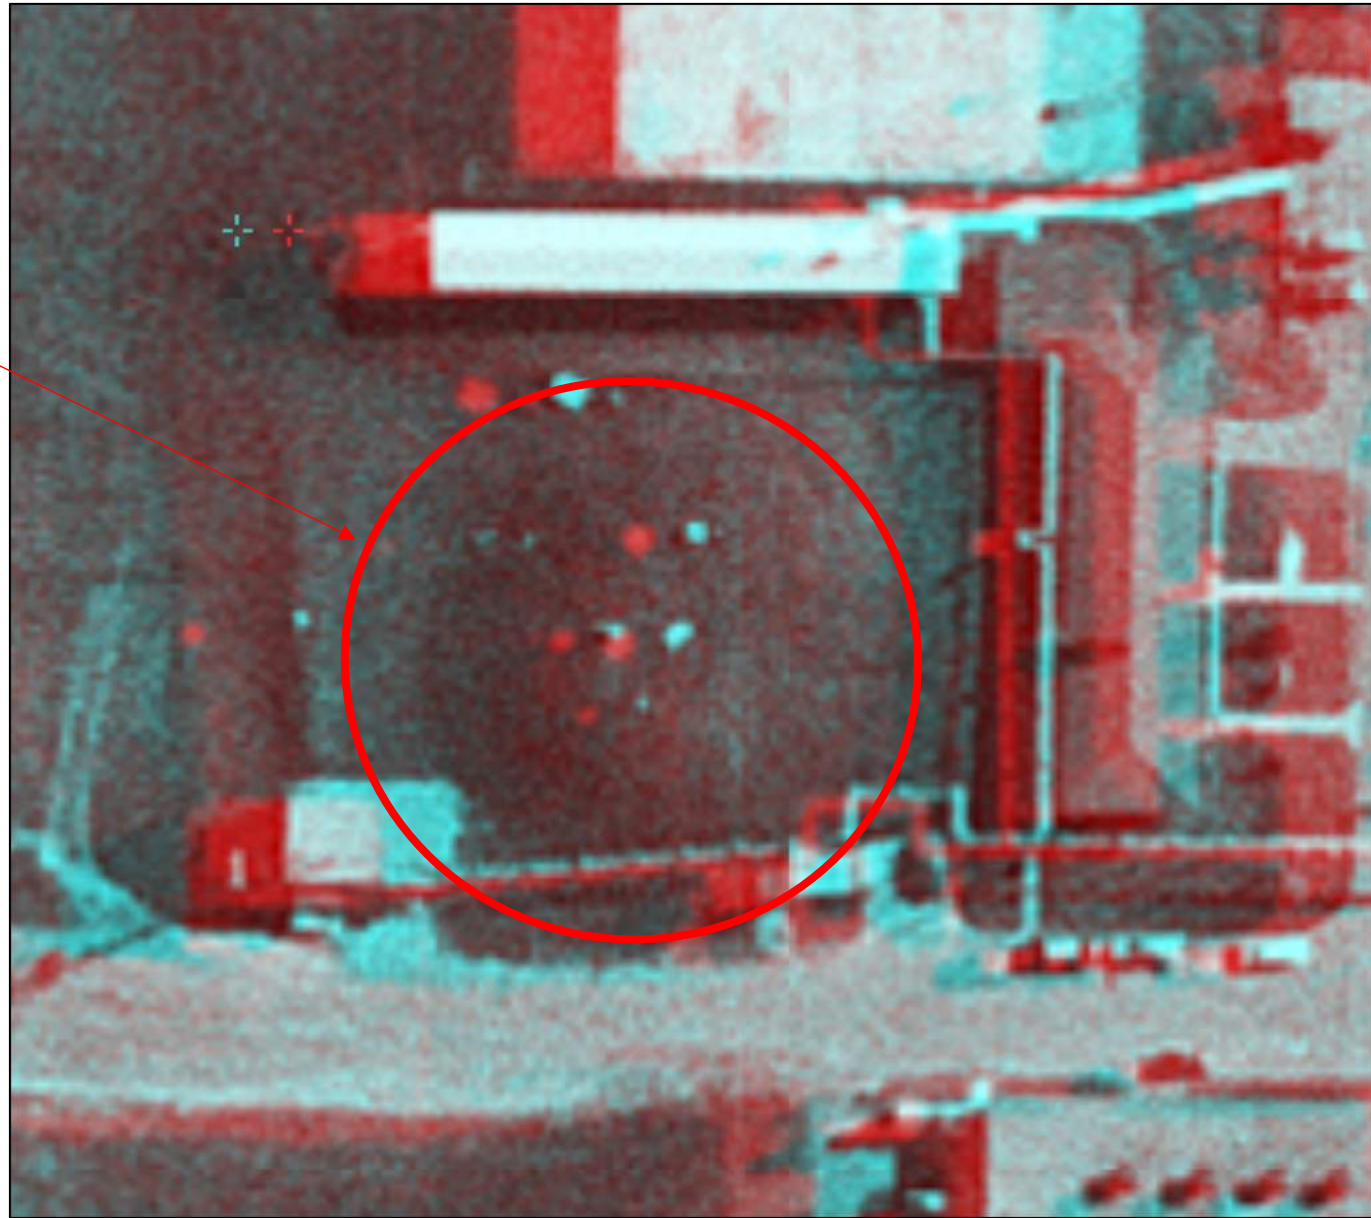
Water Tank Stereograph, 1965

Thought site of tank

Due to the nature of demolition, there would be a low chance the tank was removed.

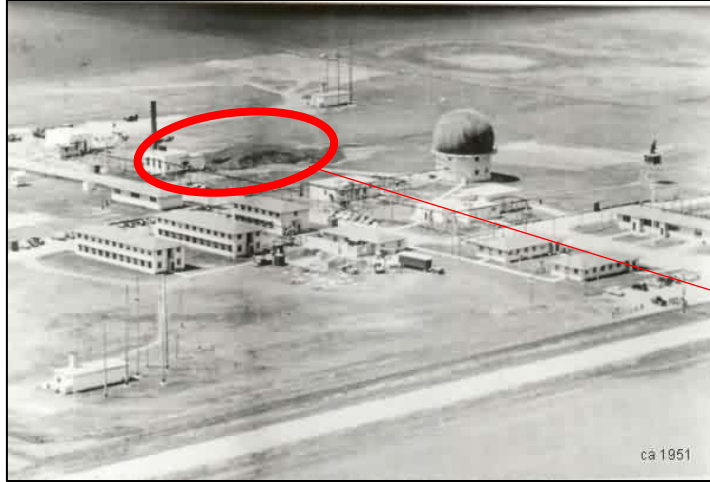
Coal pile seen from oblique photo (1951)

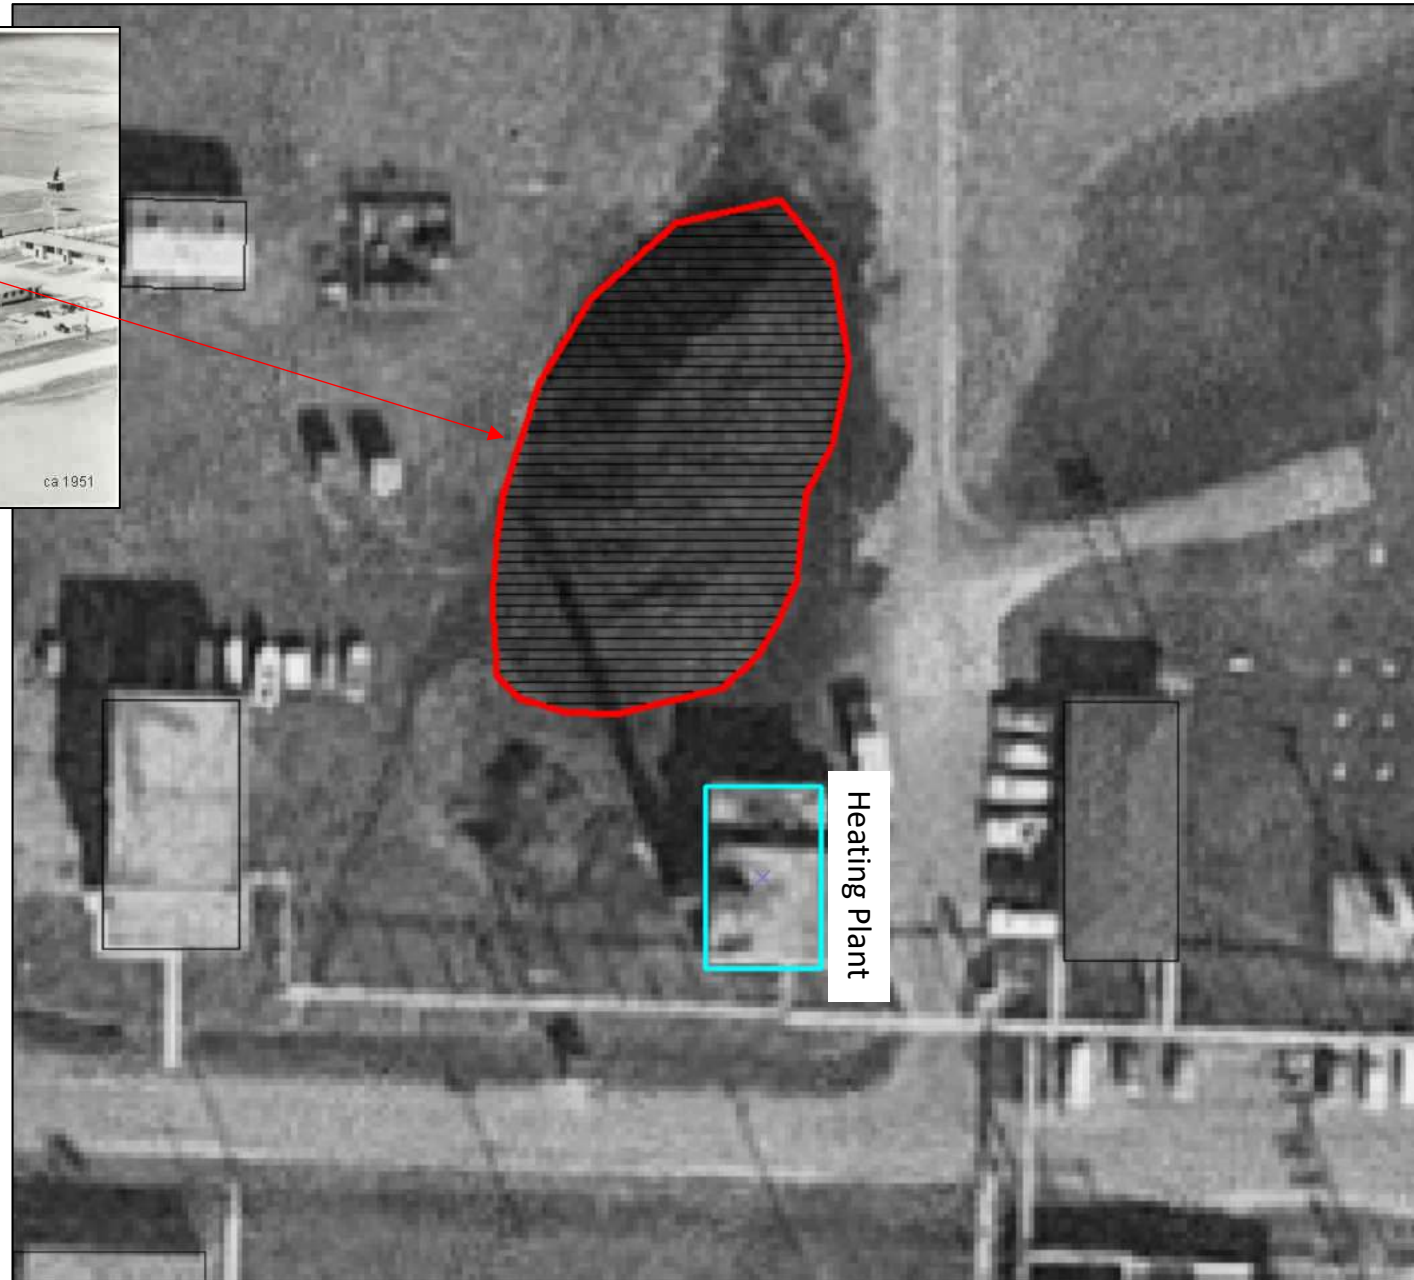
Coal/Heating Plant, 1965

The base itself was heated by a central heating plant, fed by coal. There is a fairly large pile of coal on site, right next to the heating plant itself. Easily seen in stereo, and on aerial and oblique imagery.

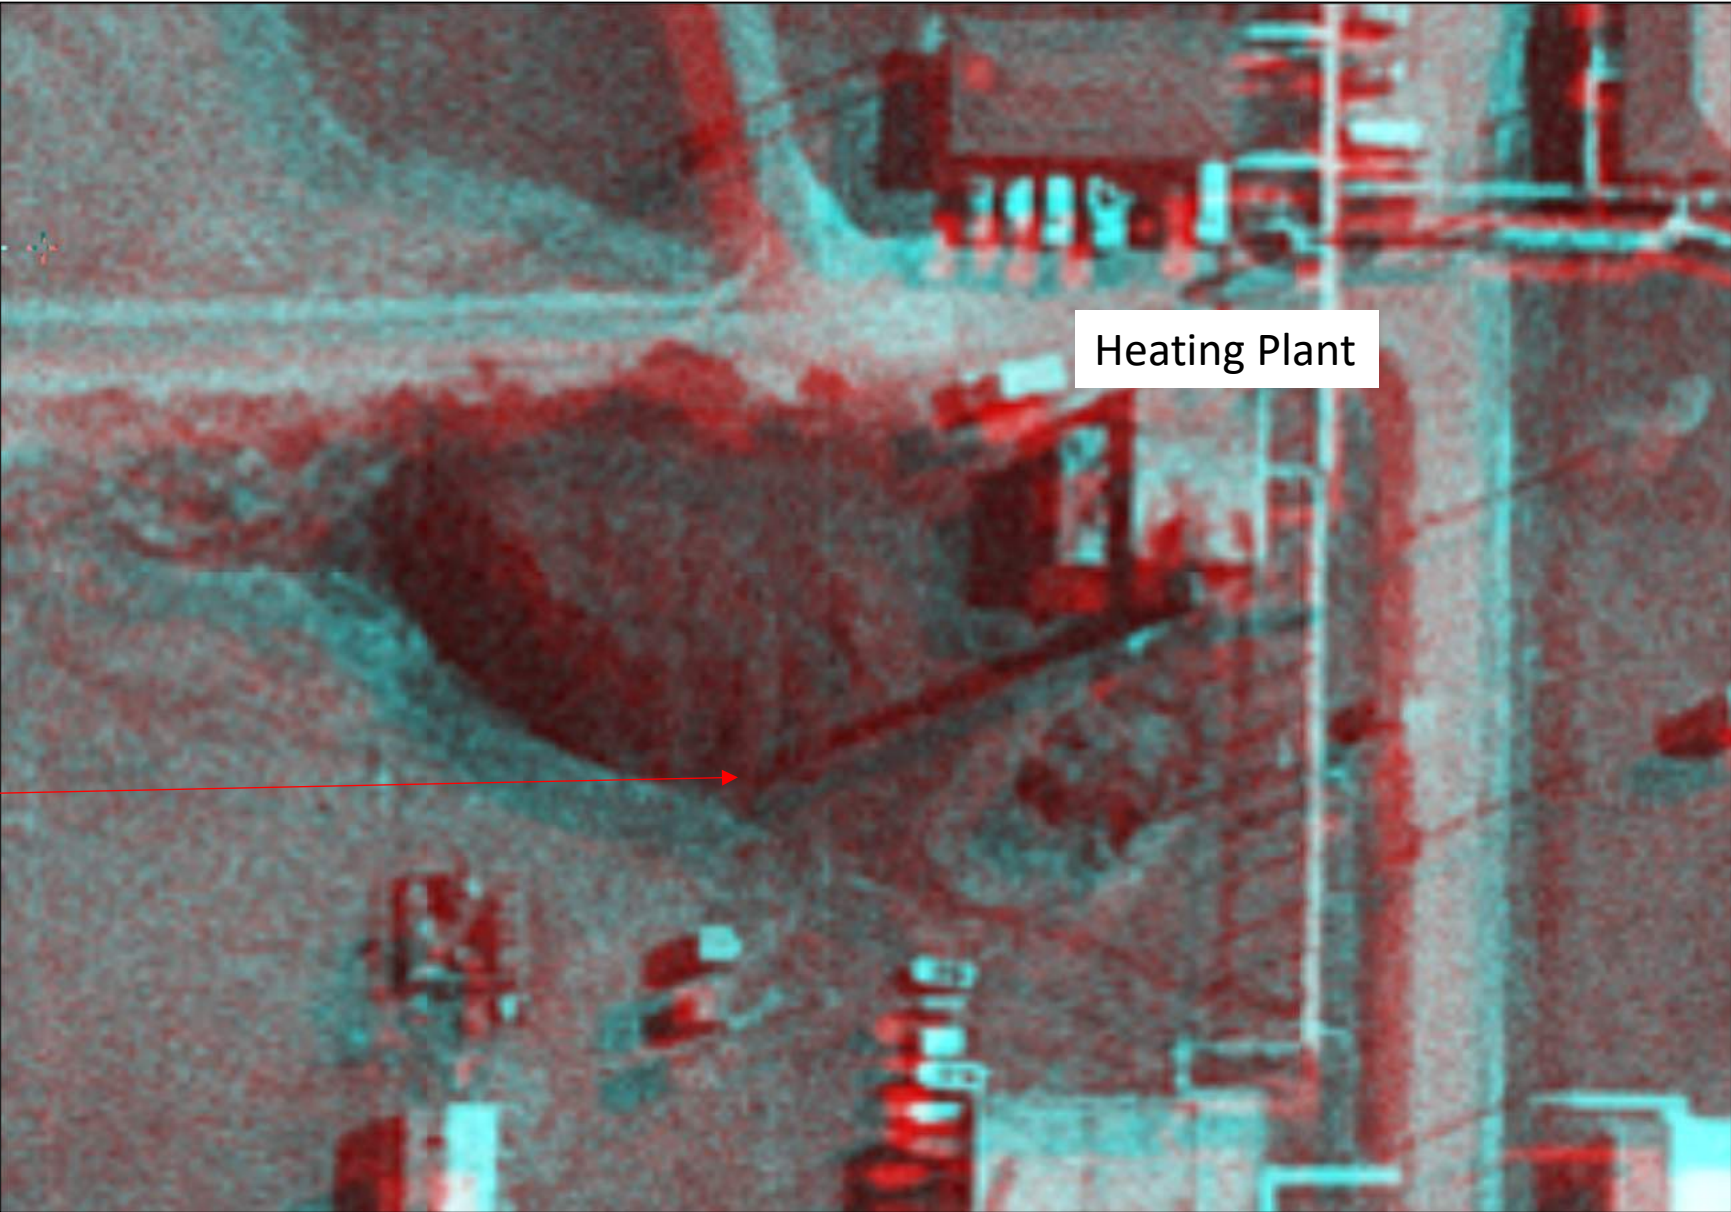
Coal/Heating Plant Stereograph, 1965

Relief of the coal mound can easily be seen in stereo imagery. Also ground disturbance to the north of the pile is noticeable.

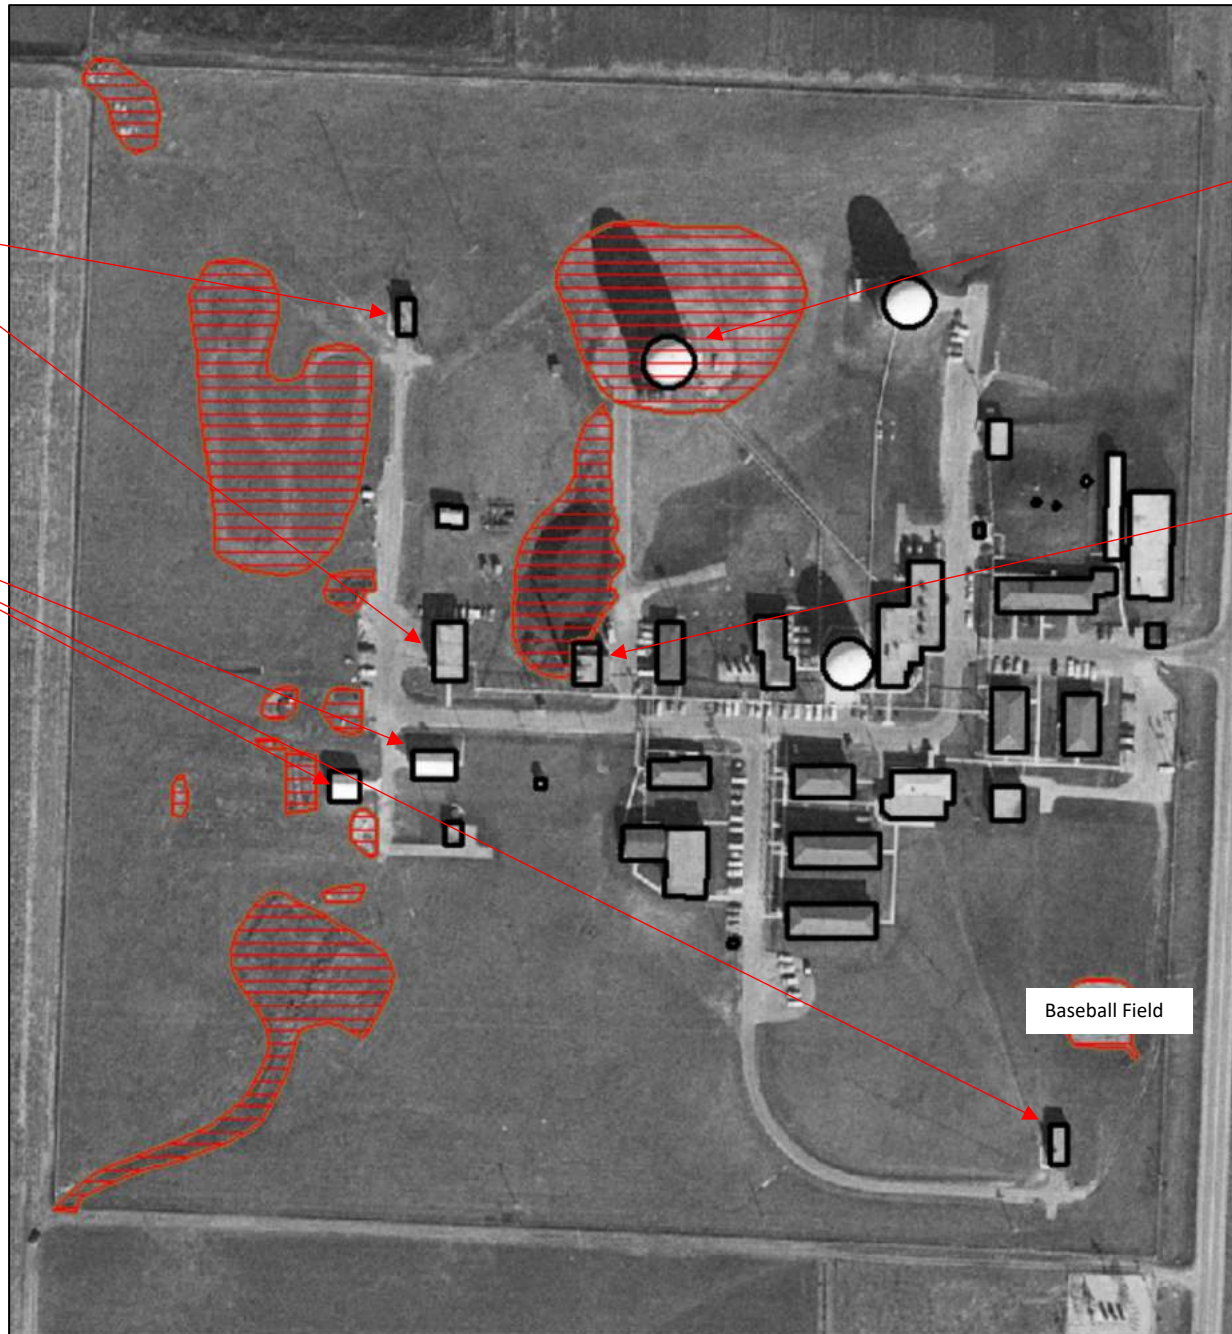
Ground Disturbances, 1965

Many spots on base can be seen to have ground disturbance, with soil being unearth, mounded, etc. These locations have been vectorized; and do seem to be found on the west side of base.

Spots of most disturbance seem to include auto shops/hobby shop, heating plant, and one of the radar towers.

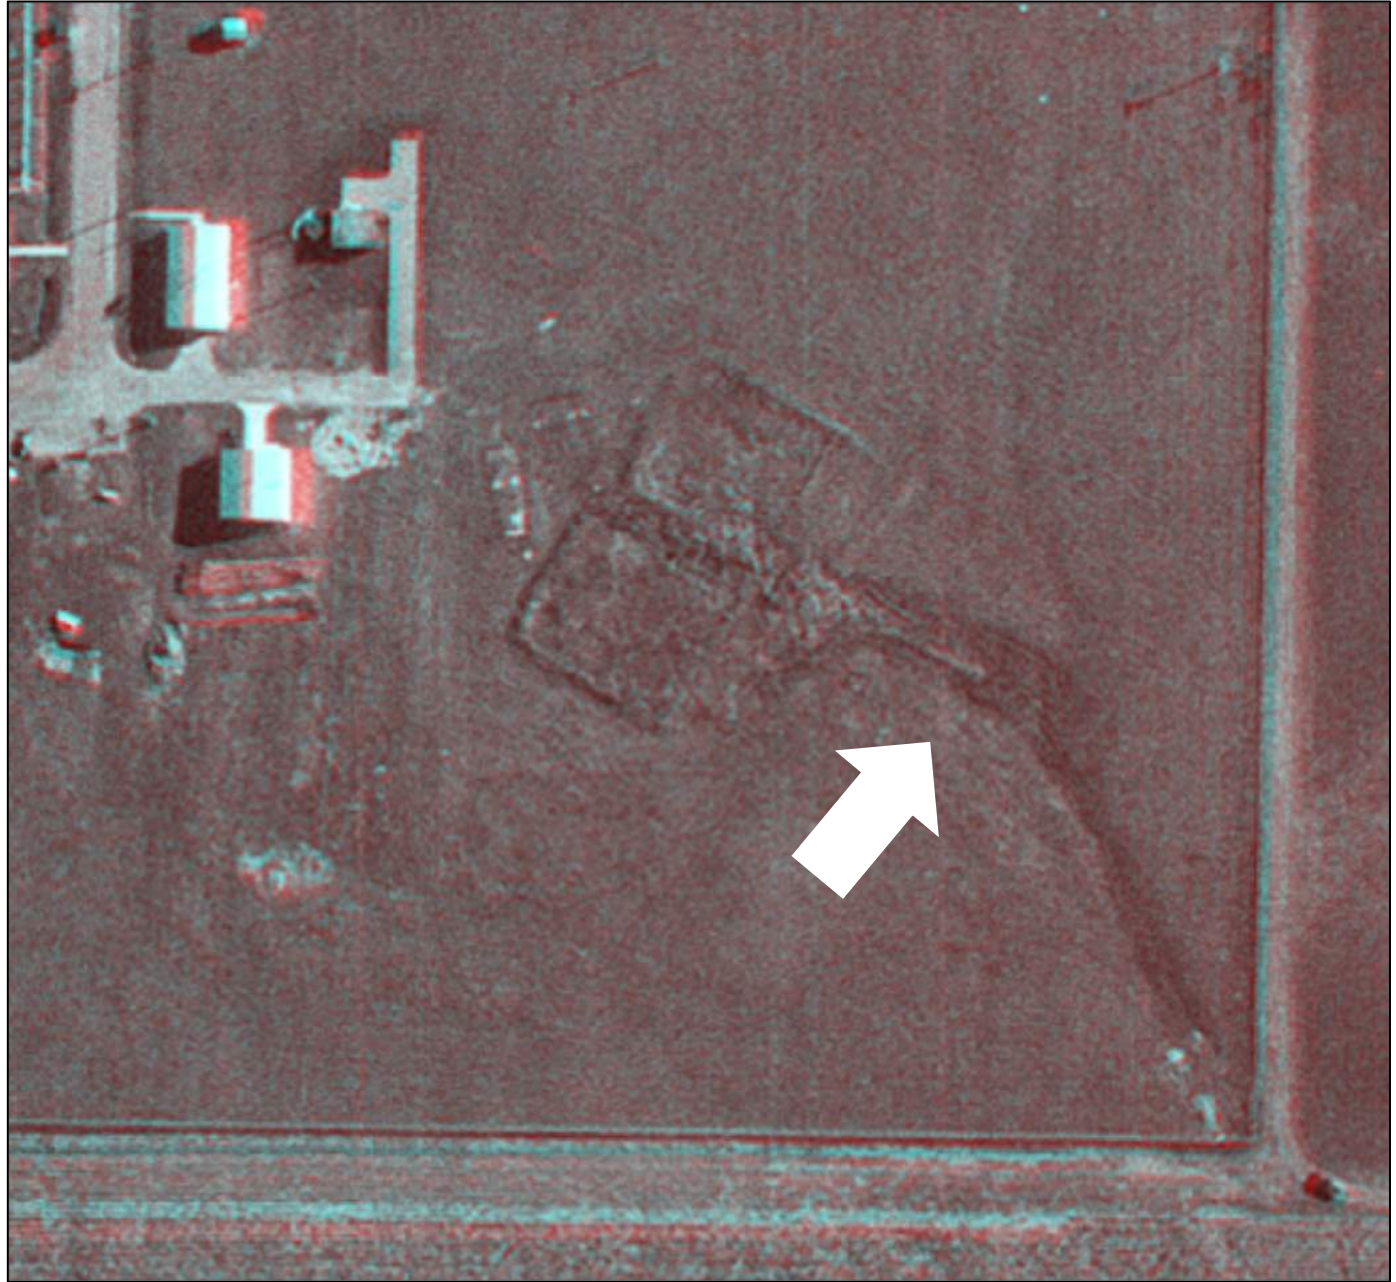
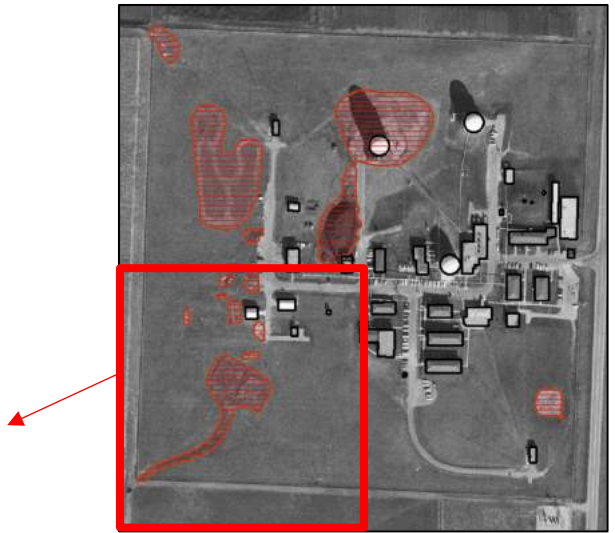
Ground Disturbance (SW corner) Stereograph, 1965

There is some sort of drainage in the SW cover of the base, leading to the corner fencing. There is some obvious disturbance of gouging and mounding.

Possibly could have a connection with sewage pond. (See Next Section)

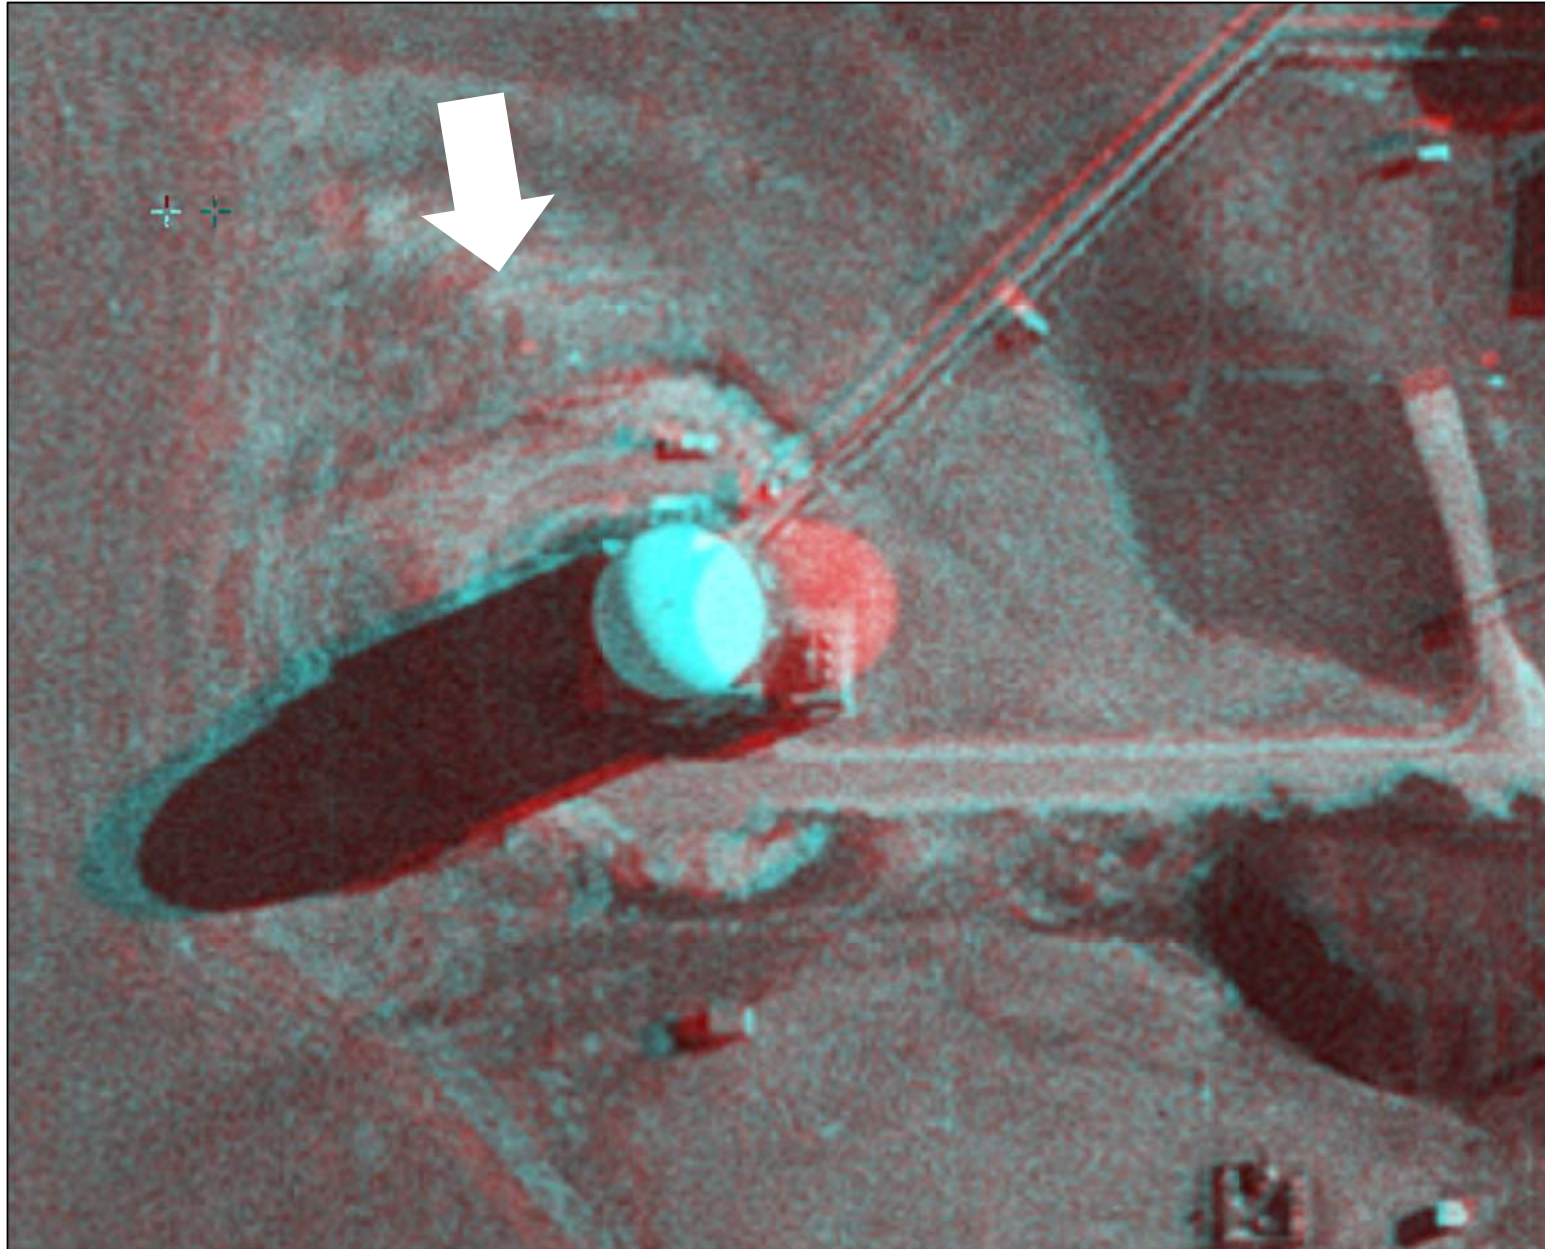
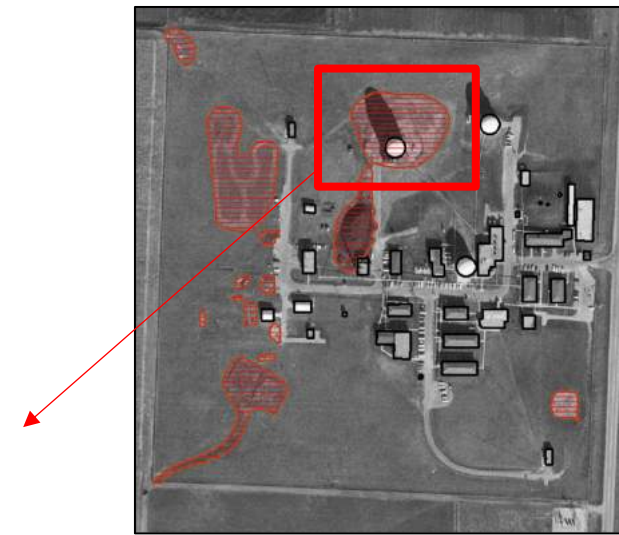
Ground Disturbance (Radar Tower) Stereograph, 1965

There is obvious ground disturbance surrounding one of the radar towers. Could be due to being driven on; but much of the soil seems to be exposed.

Does still seem to have an effect on the landscape today. (See Next Slide)

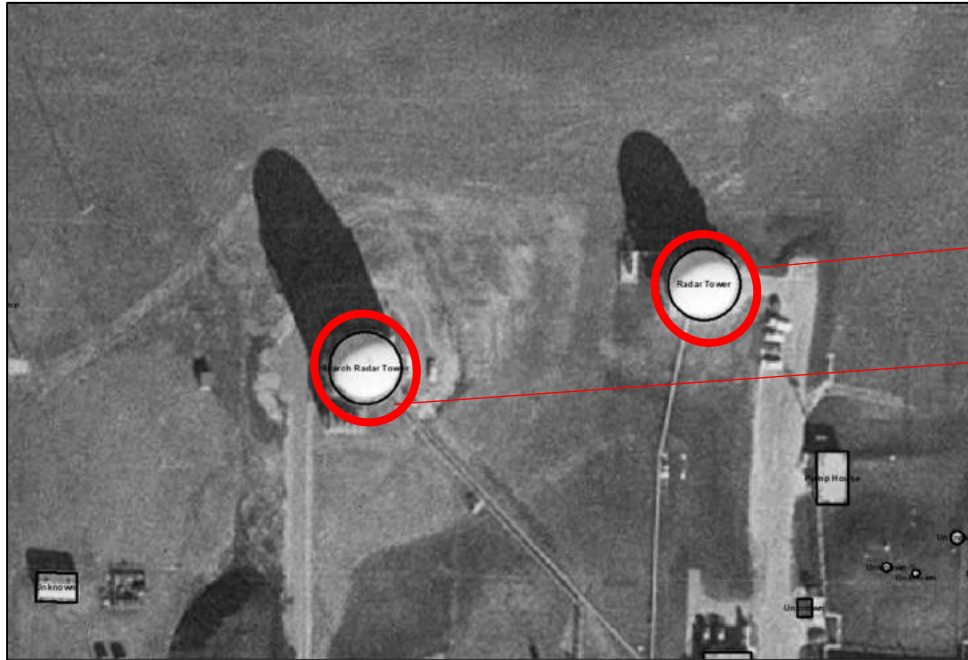
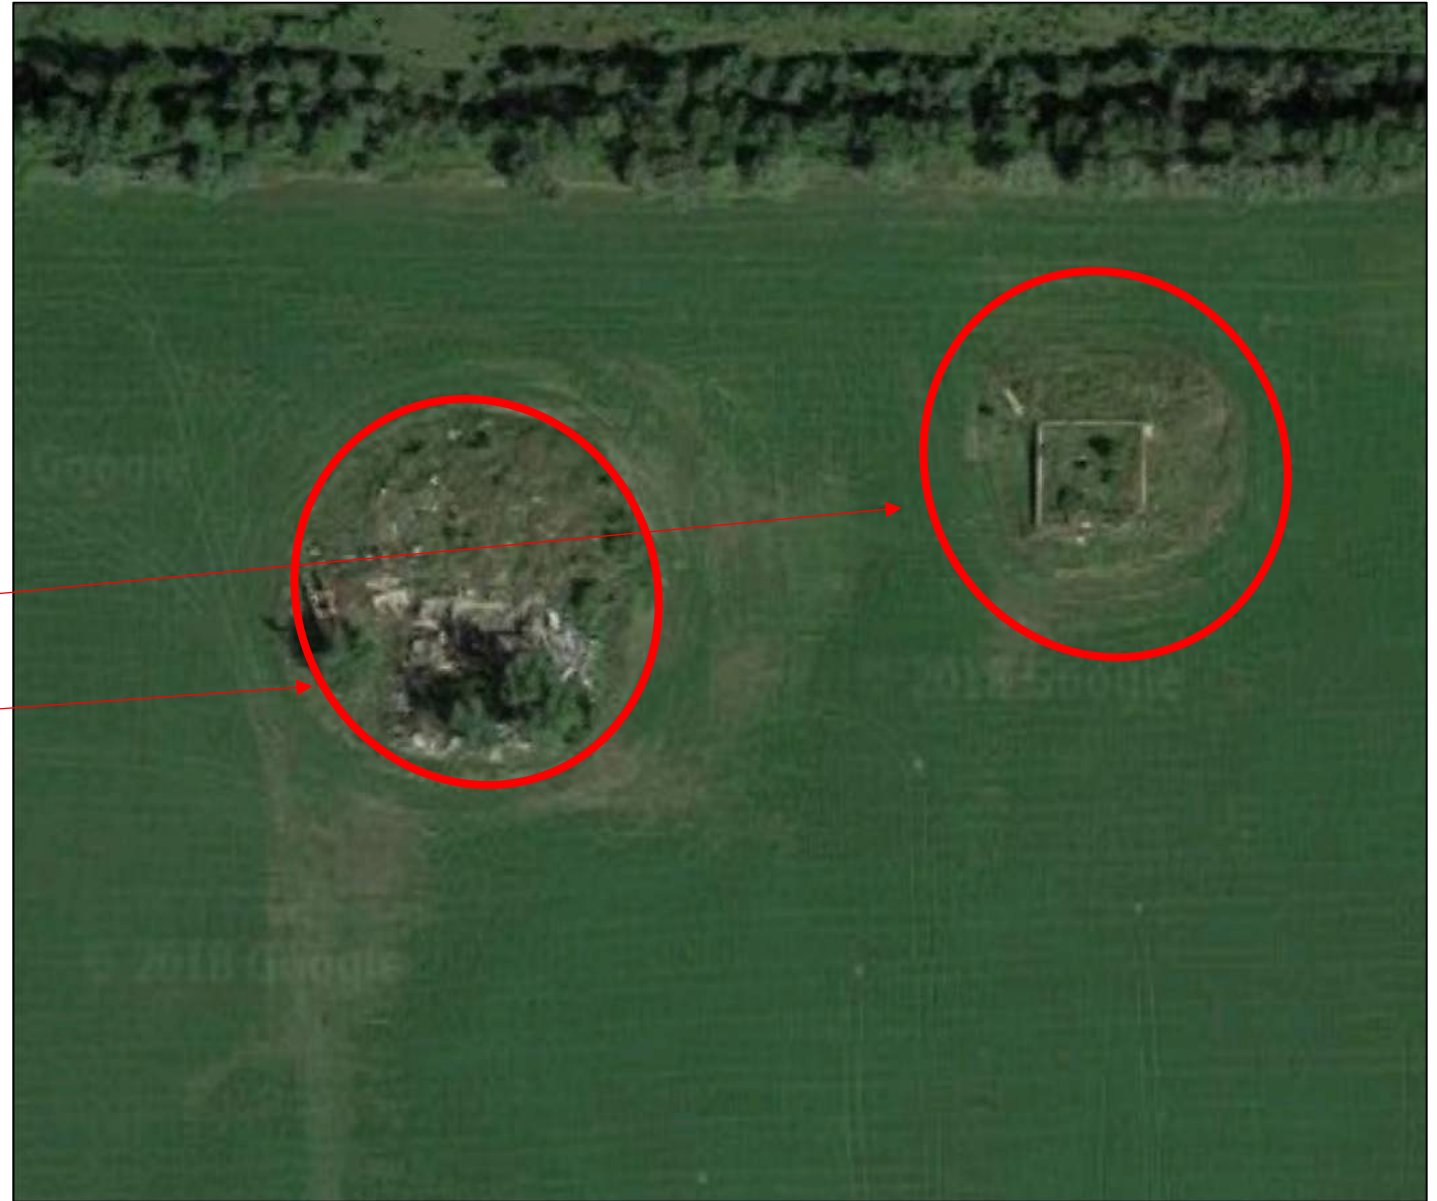
1965 v. 2018; Radar Tower Locations

Locations of the Radar towers can be spotted today by ruins of concrete and debris.

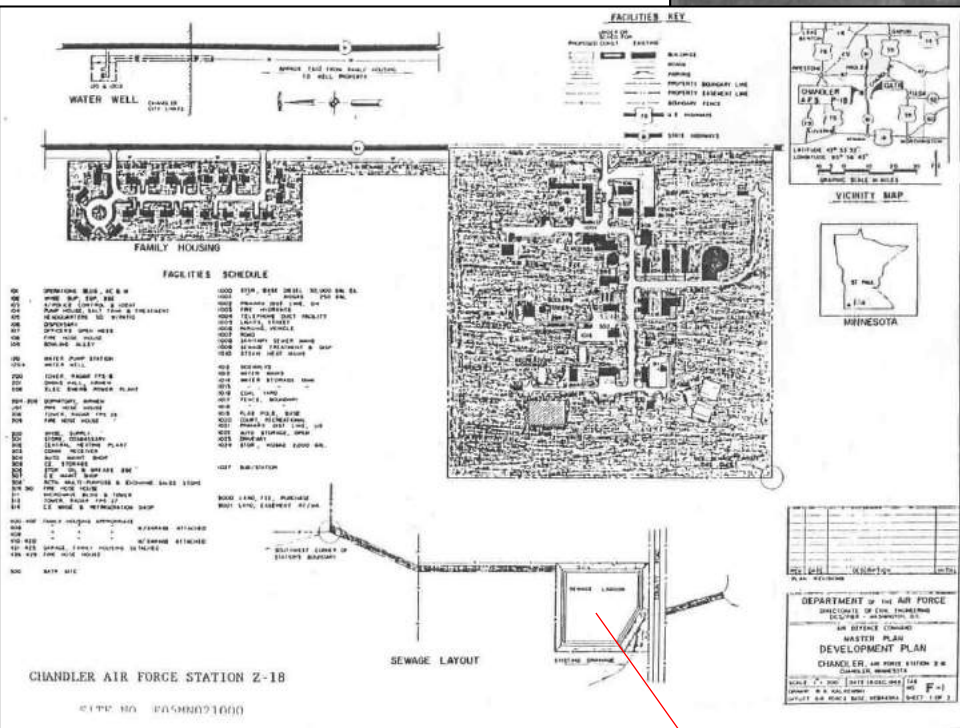
Sewage Pond, 1965

In one of the map documents, it states the usage of a sewage pond, which is south west of the camp. This definitely poses an environmental hazard if it has been untreated since use.

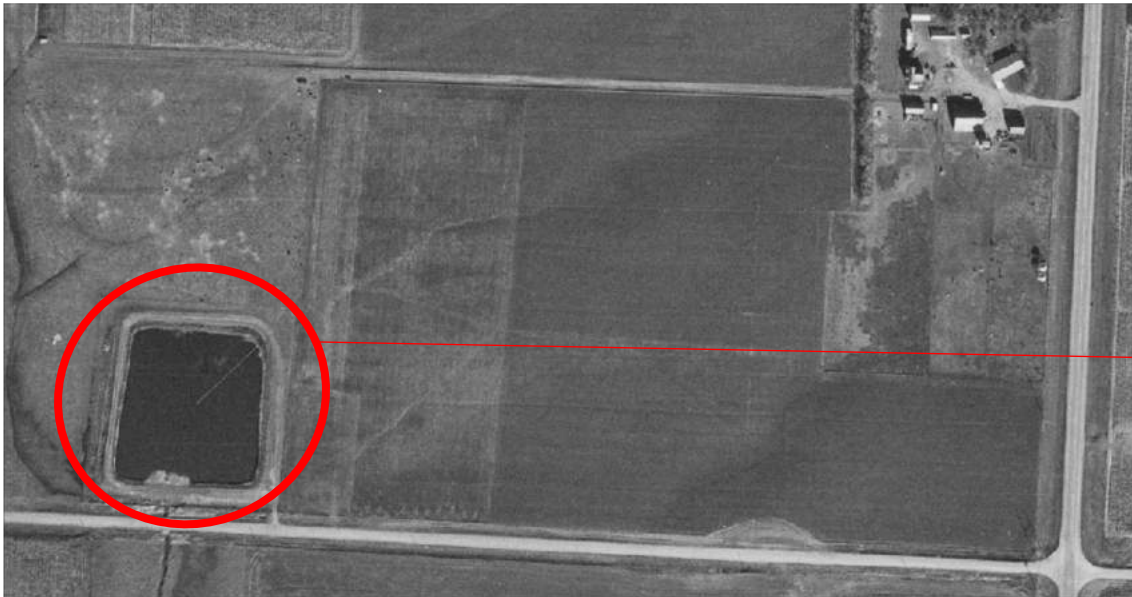
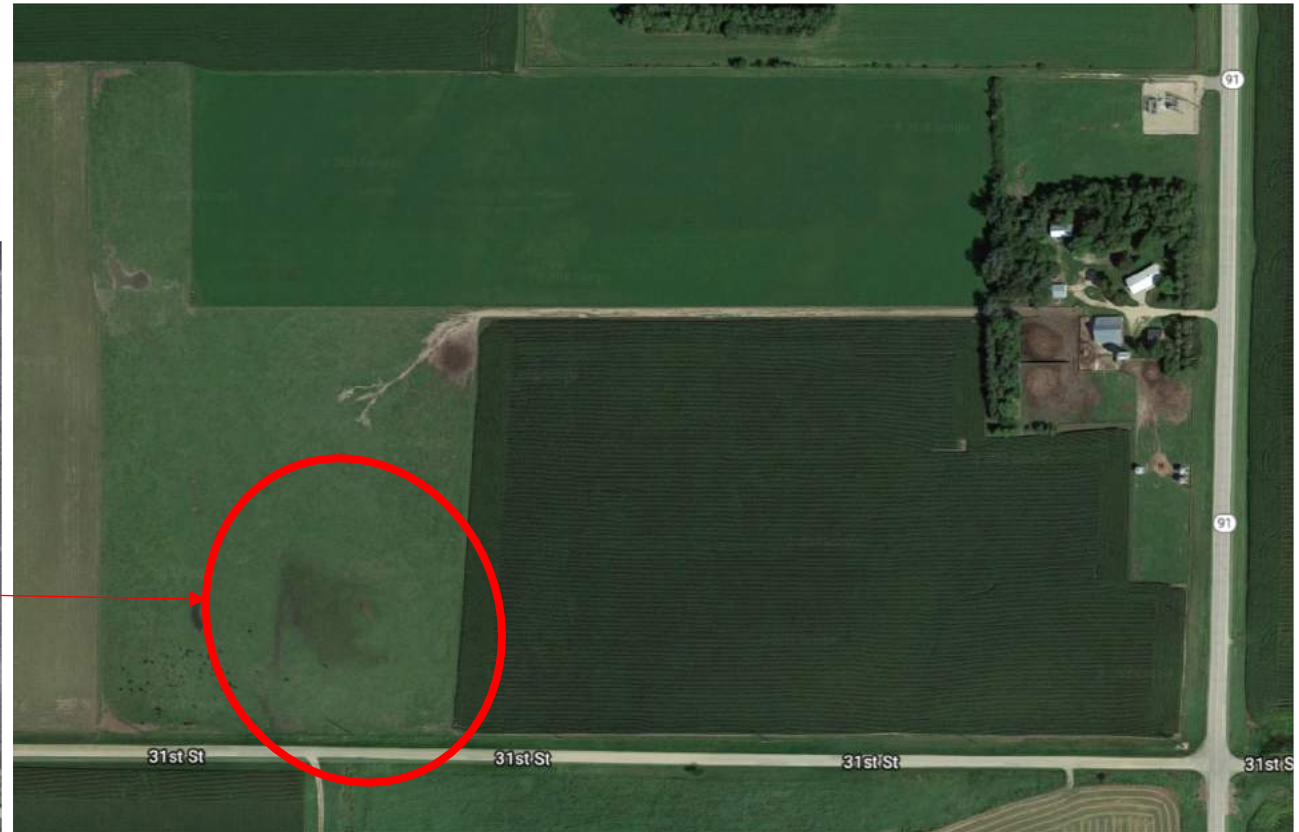
1965 v. 2018; Sewage Pond

There is still a stain on the ground from the sewage pond.
