Chandler Air Force Base

Historical Photographic Analysis

Tyler Dardis
Minnesota State University, Mankato
GEOG 480 – GISc and Environmental Hazards

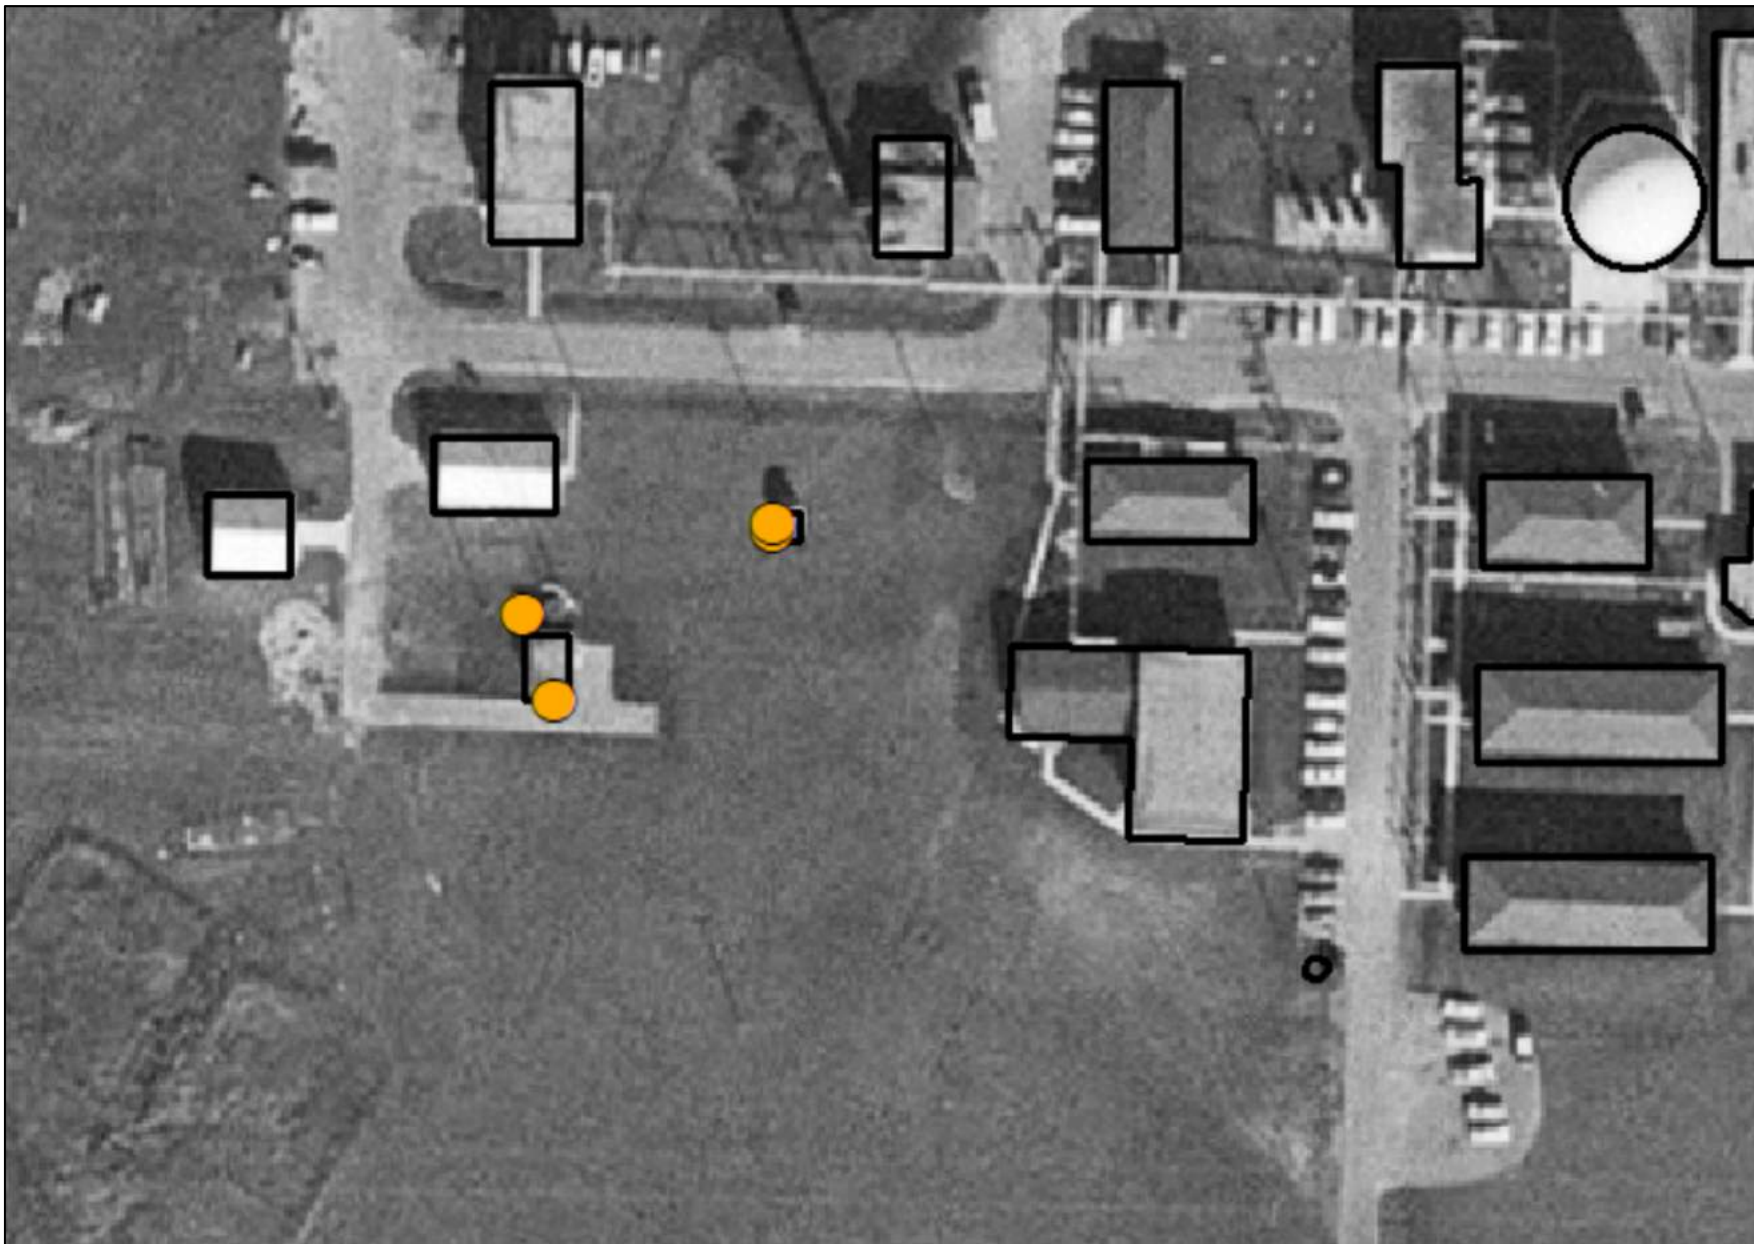
Photographic Evidence Plotted, 1965

Available photos of the site during use were observed for any hazards. Three photos were found to have hazards. Points are plotted.

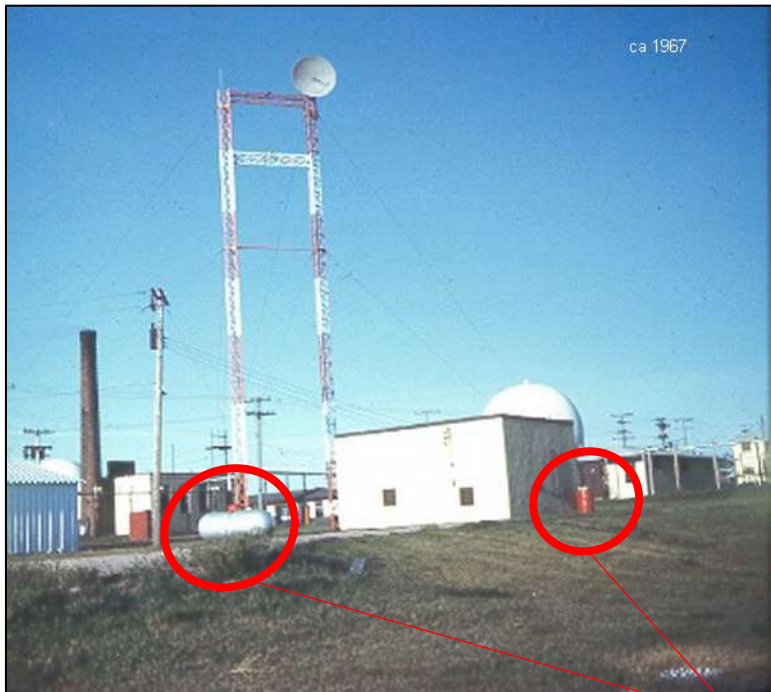
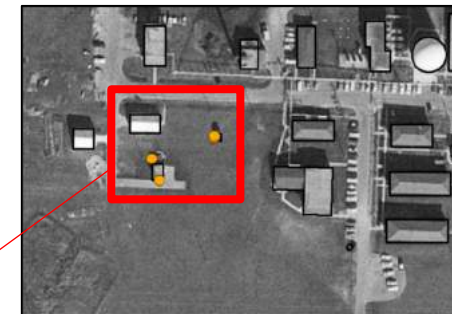
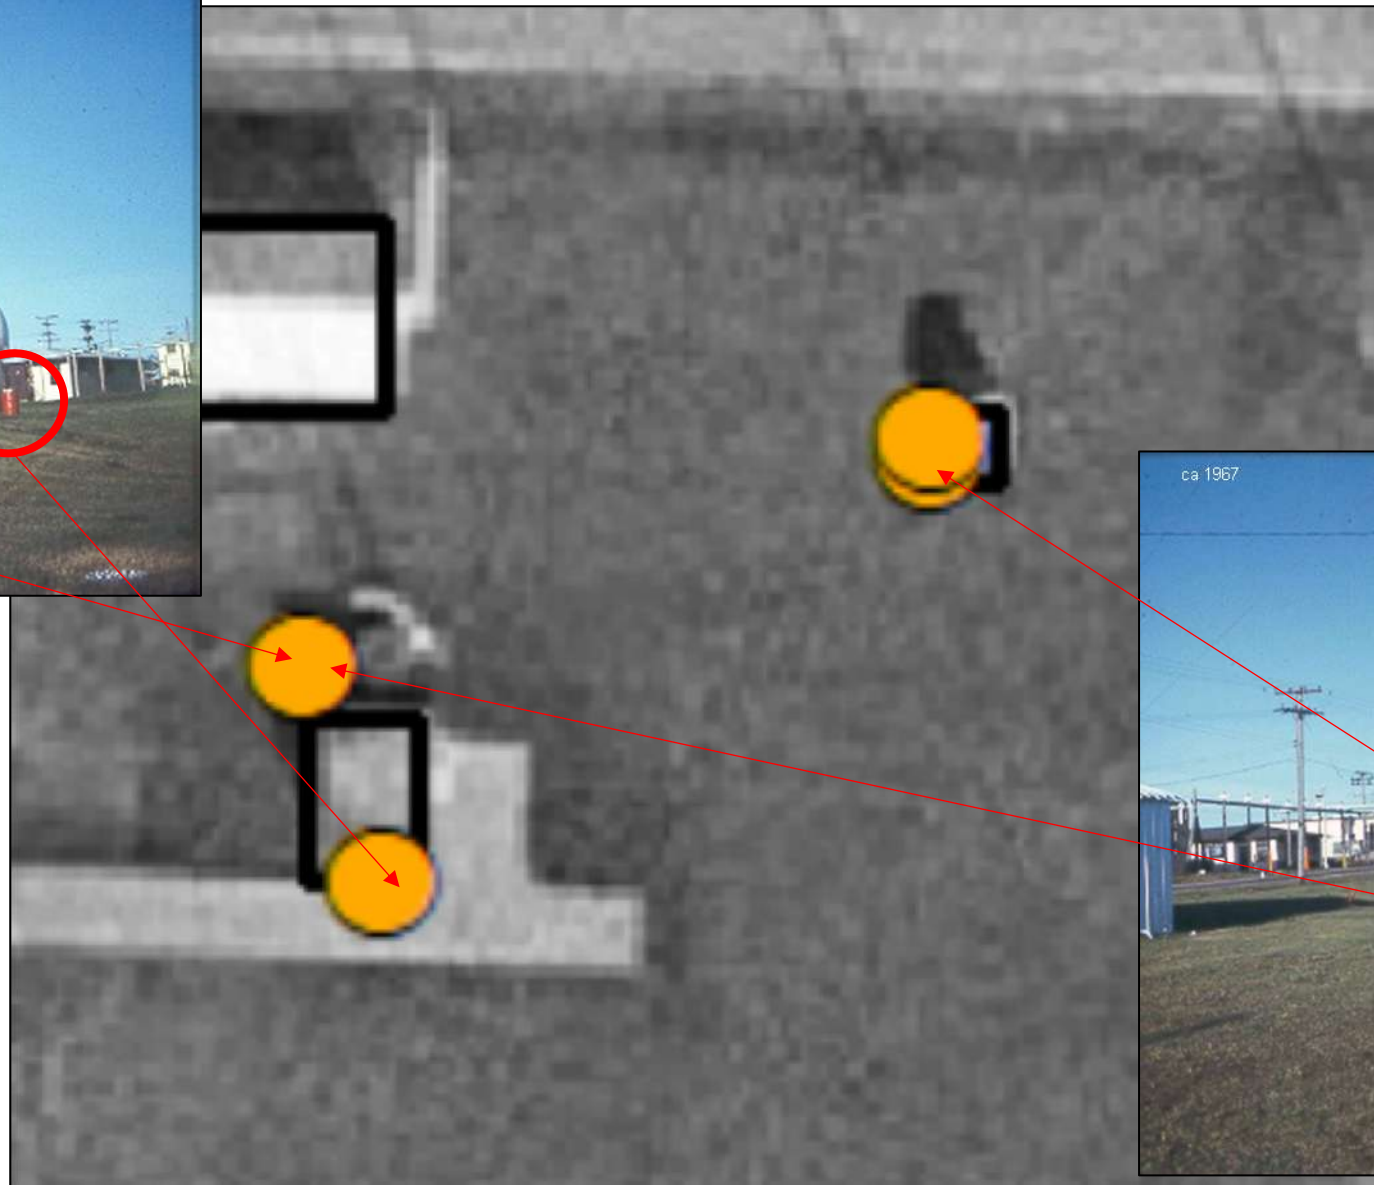
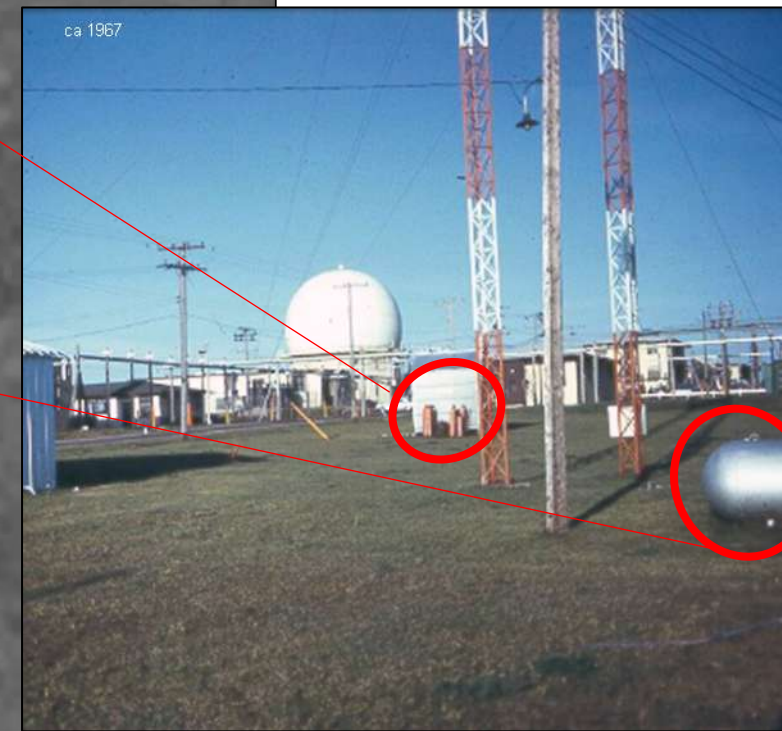
Photographic Evidence, 1965

Barrels and tanks were found through the images; bringing up concern about hazards, as well as explaining possible usage of the corresponding building.

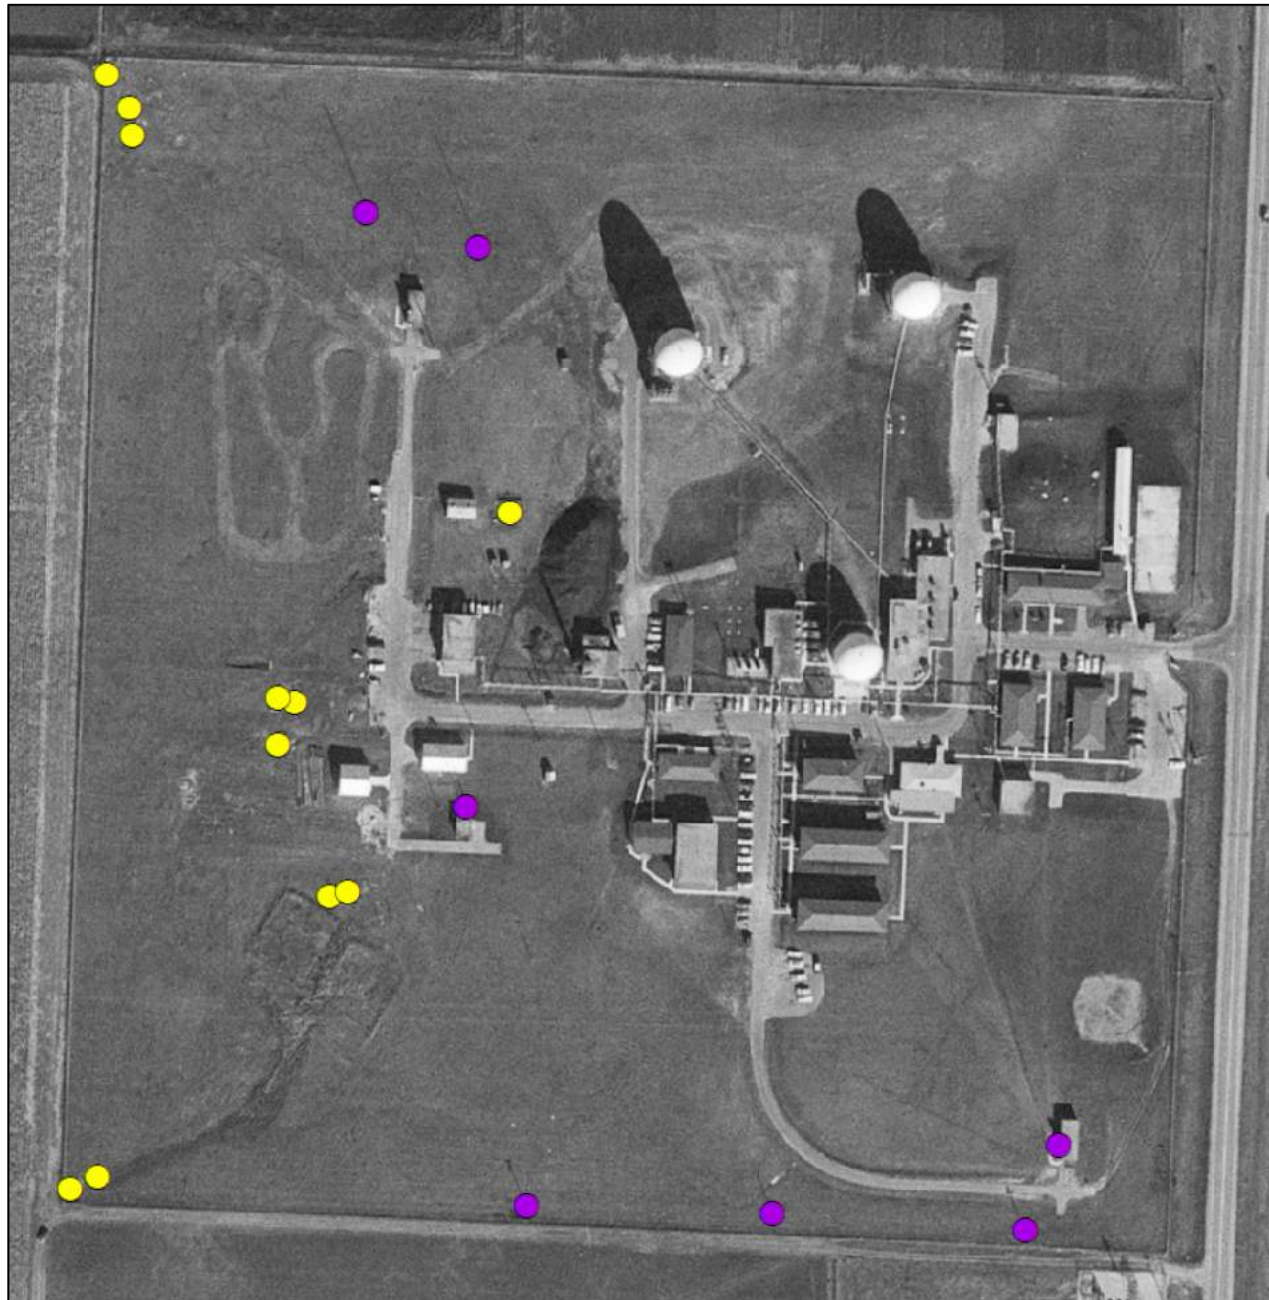
Debris from Aerial Photography, 1965

There are many locations that have objects that are unknown. It is presumably some debris, trash; something protruding from the ground. Since it is an unnatural feature, they are marked and mapped here.

Antenna's are also mapped

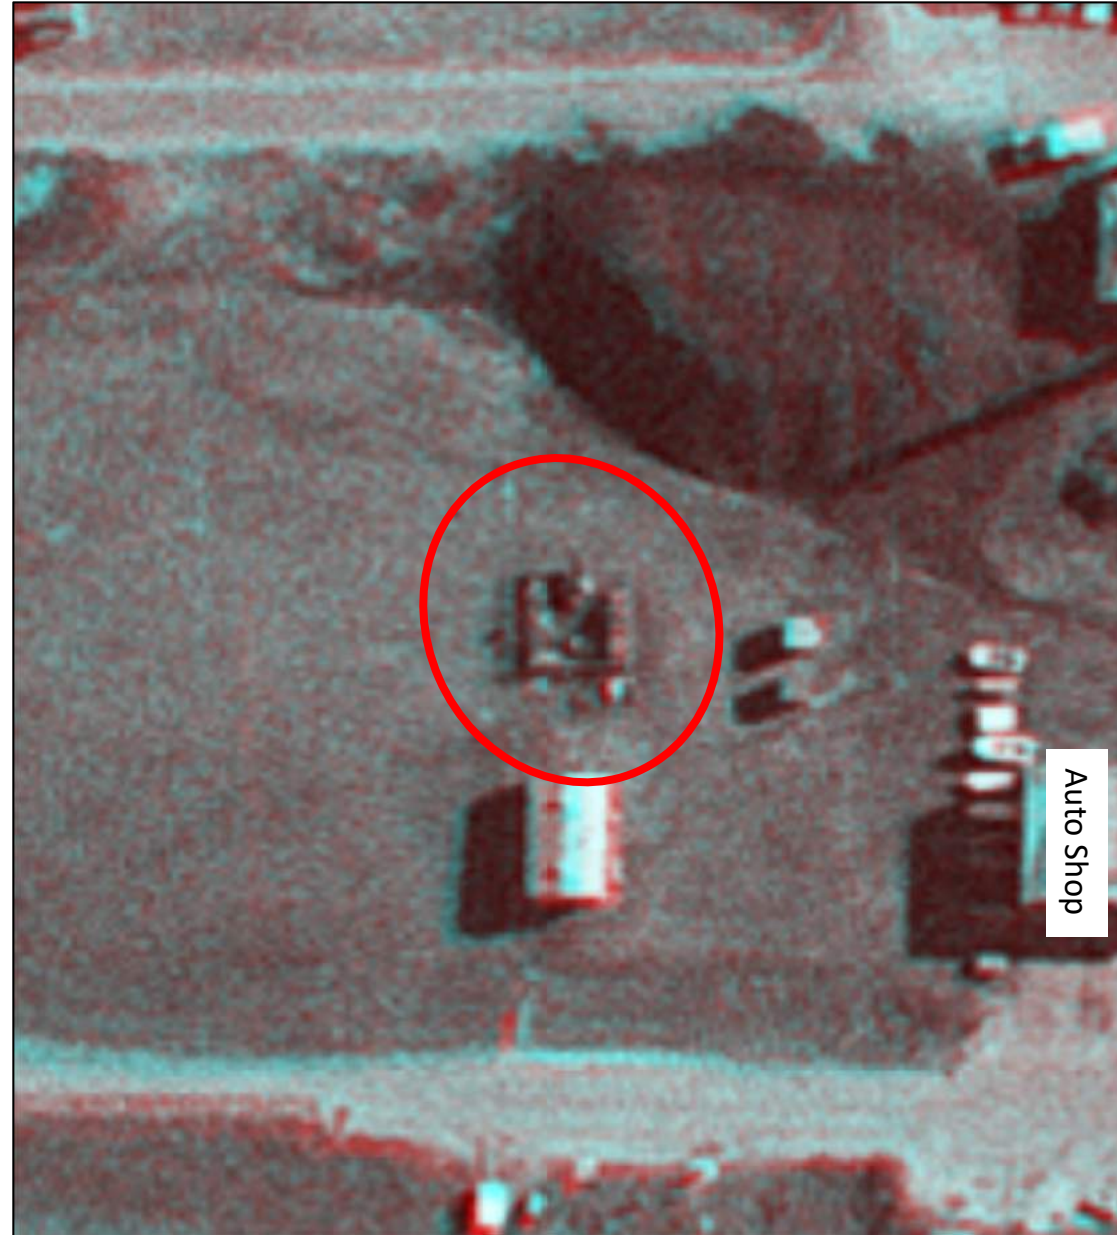
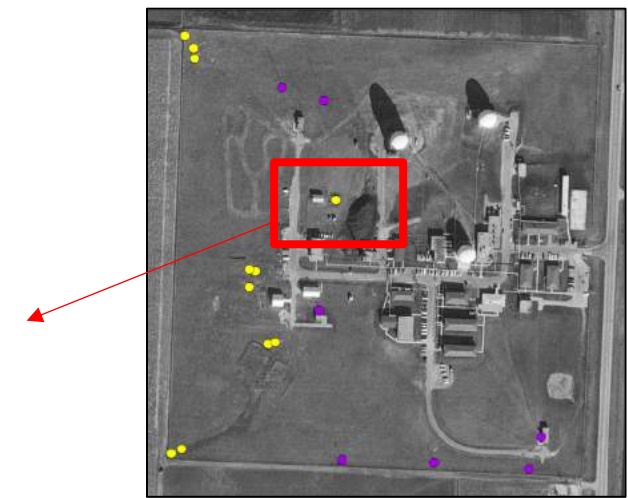
Debris from Aerial Photography, 1965

Above a building with an unknown function, but in the same proximity as the auto shop.

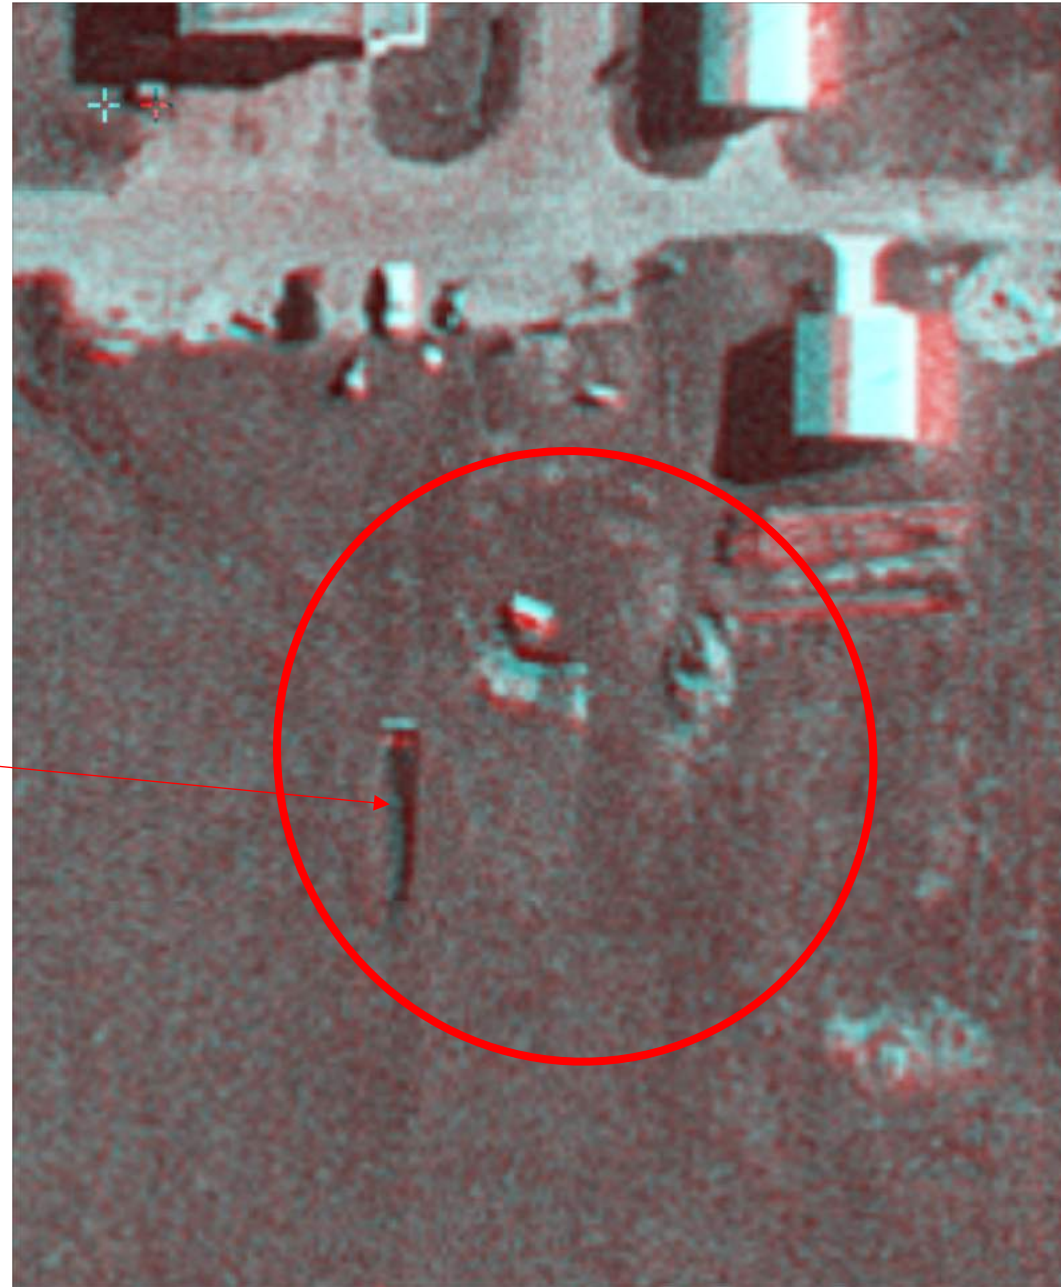
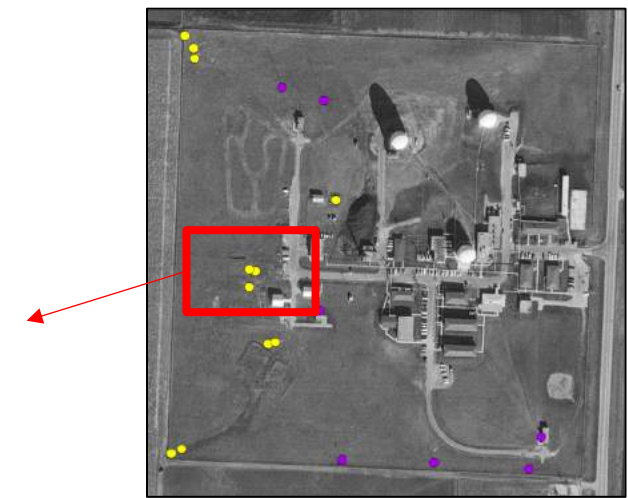
Debris from Aerial Photography, 1965

Debris seen by the nearby supply warehouse, as well as auto shop. Combination of disturbed ground and debris.

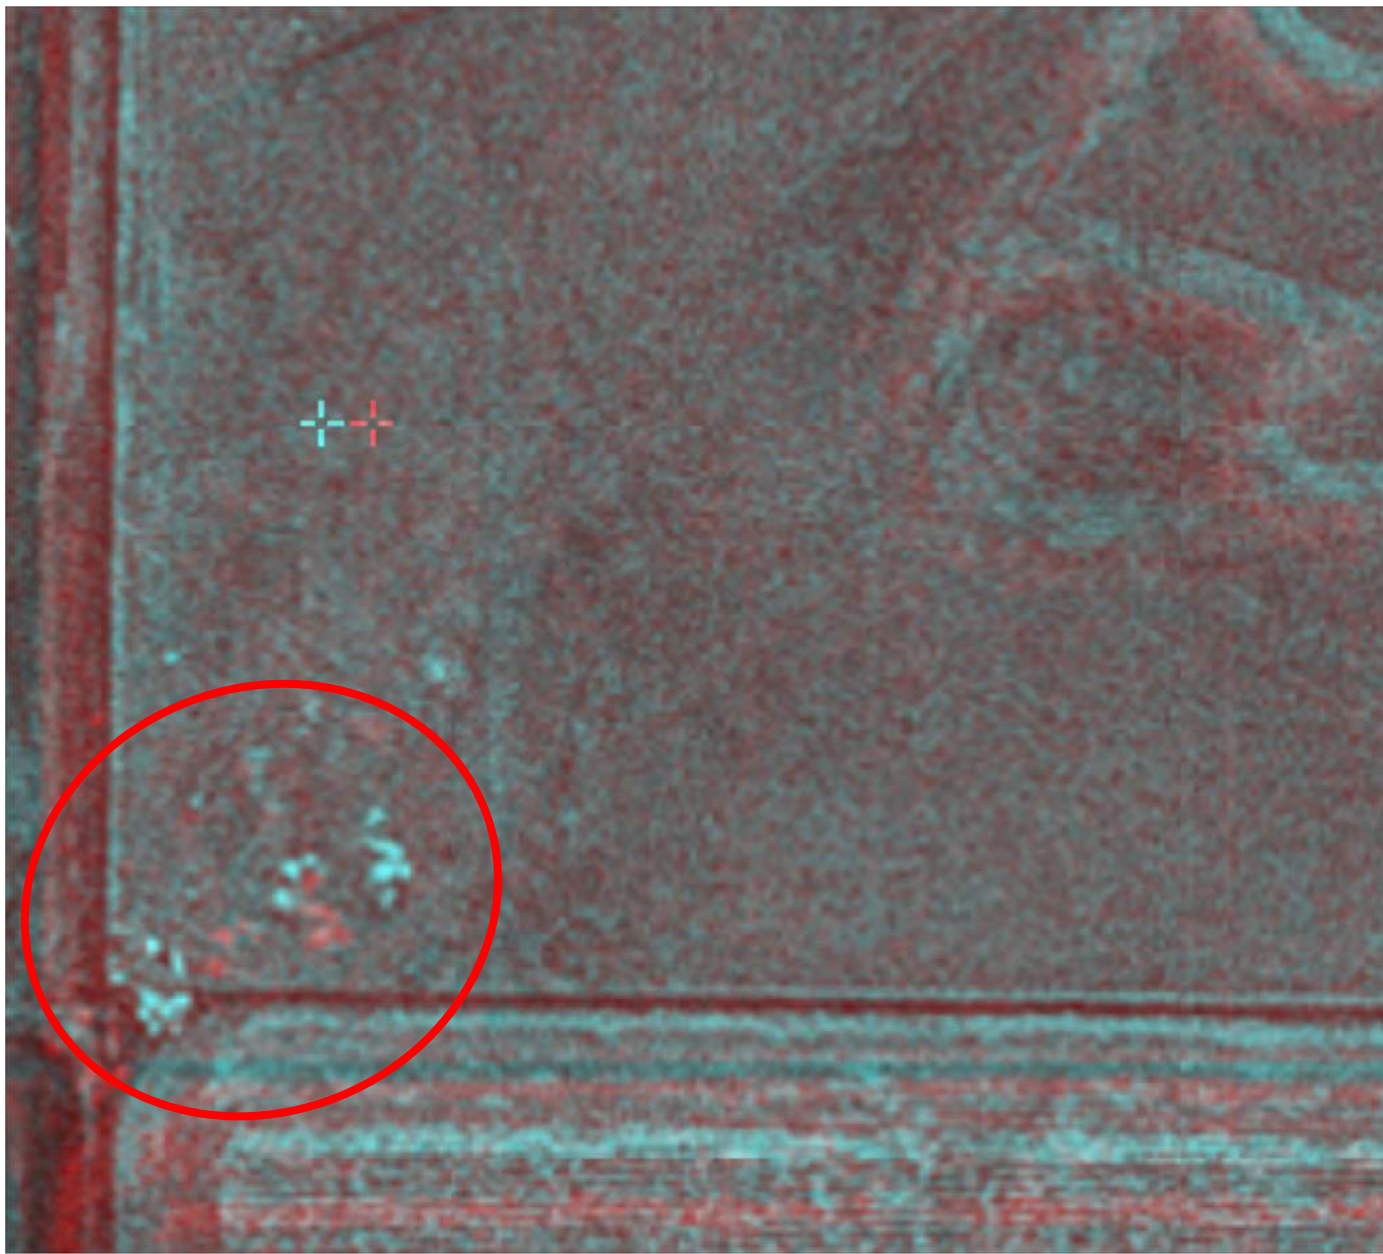
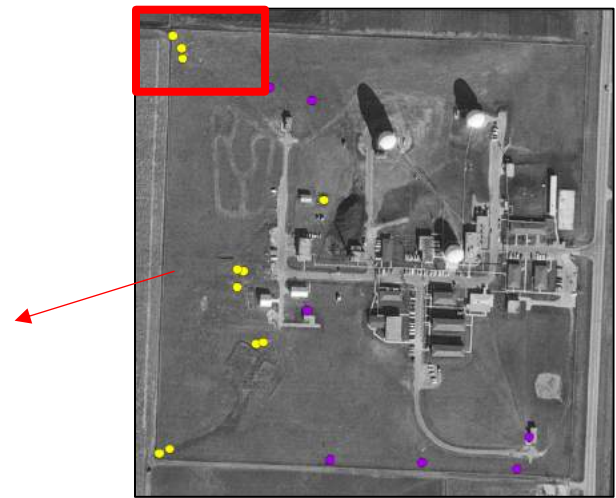
Debris from Aerial Photography, 1965

Unknown debris seen in the north west corner. Closest to hobby shop and possible race track.
